**Subject:** Fitzsimmons Creek Flood Protection and Maintenance Program  
2022 Fitzsimmons Creek Completion Report  
Water Approval Reference: A2006185

This memorandum documents the completion of gravel removal within Fitzsimmons Creek undertaken as part of the 2022 Fitzsimmons Creek Flood Protection and Maintenance Program.

TITLE:  
**FITZSIMMONS CREEK FLOOD PROTECTION PLAN  
2022 GRAVEL REMOVAL**

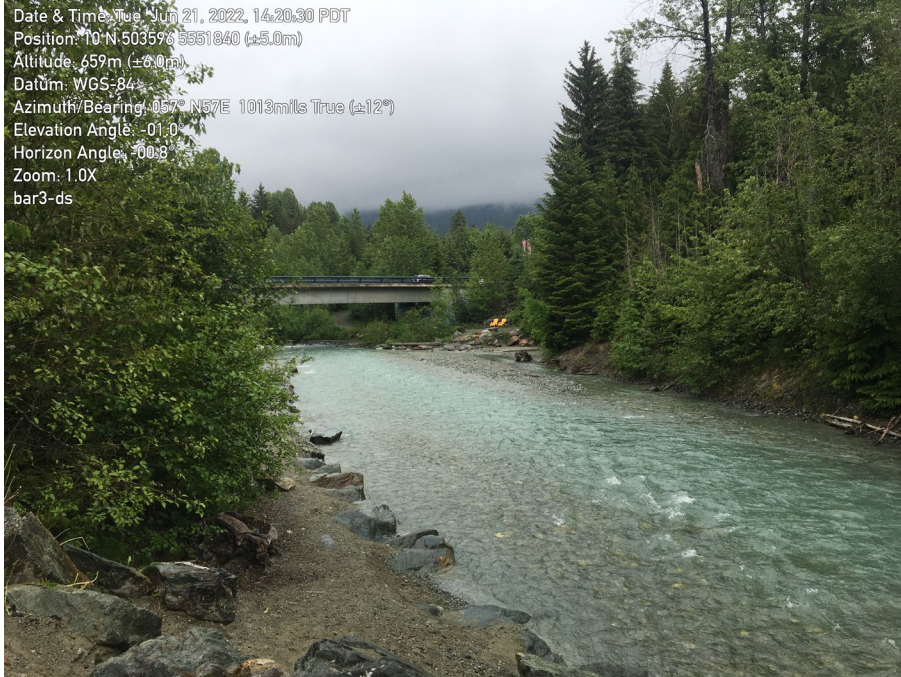
**Photo 1:** Gravel Bar #3 facing downstream. Estimated gravel extraction volume = 255 m<sup>3</sup>.

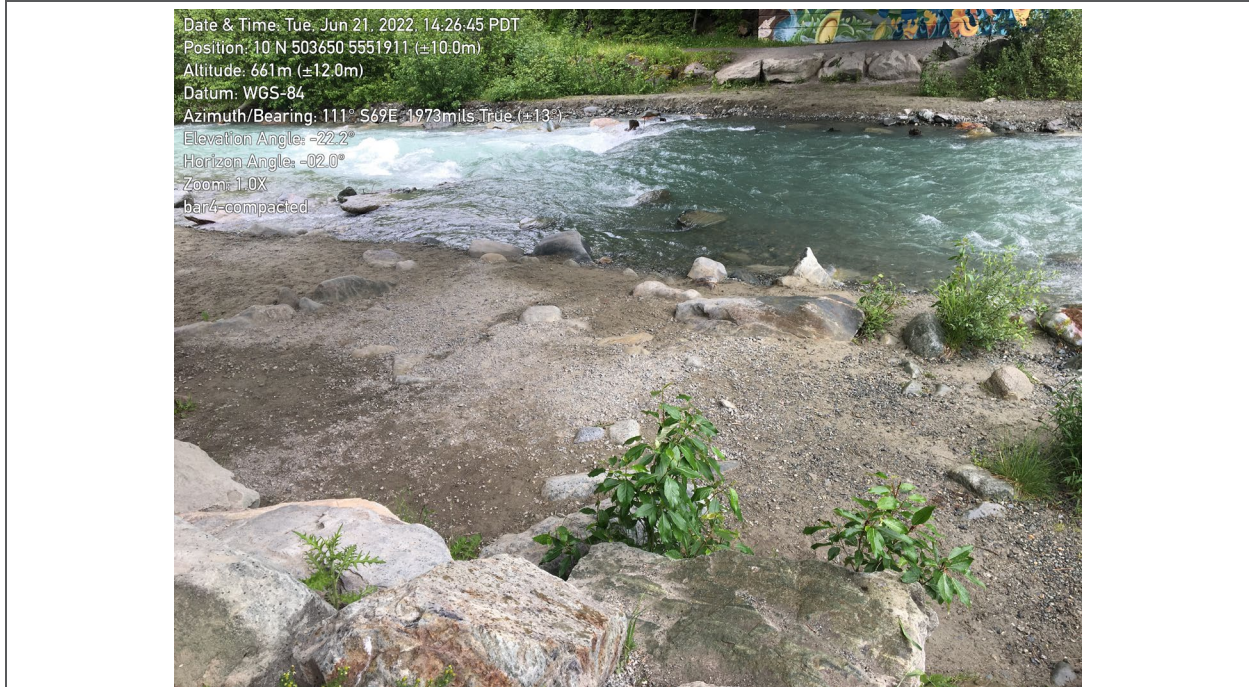
**Photo 2:** Gravel Bar #4 compacted. Estimated gravel extraction volume = 337 m<sup>3</sup>.

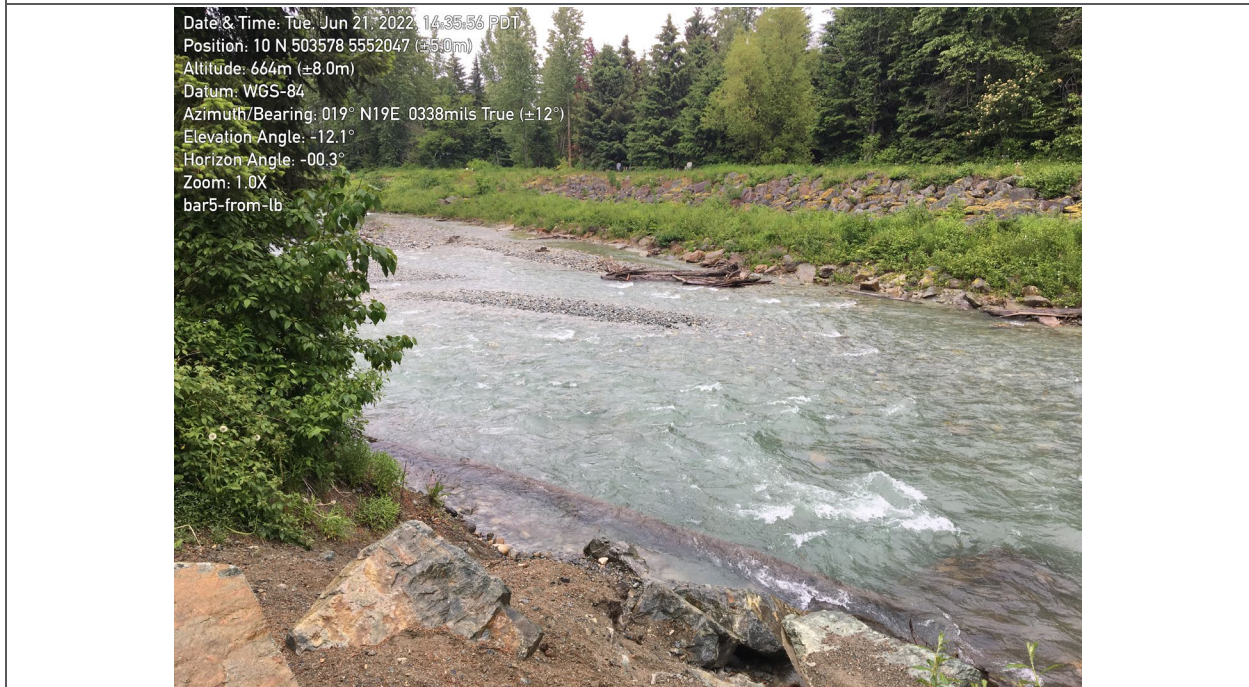
**Photo 3:** Gravel Bar #5 from left bank. Estimated gravel extraction volume = 1,644 m<sup>3</sup>.

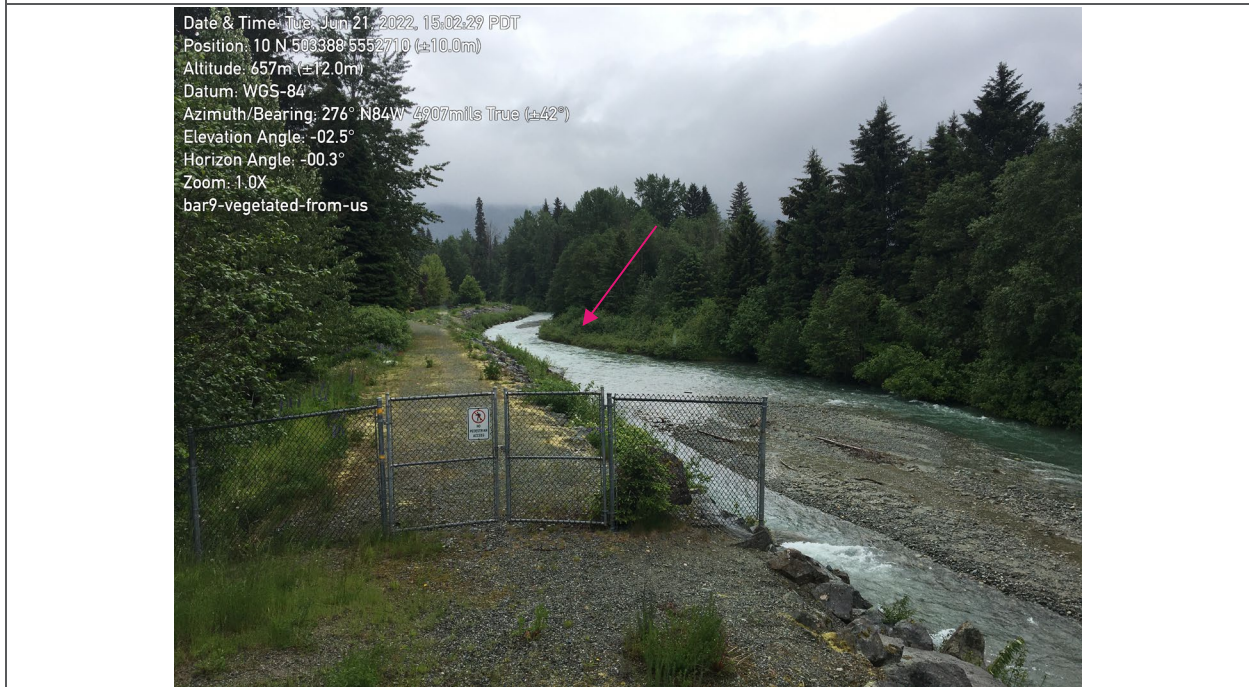
**Photo 5:** Gravel Bar #9 prior to excavation. Estimated gravel extraction volume = 1,402 m<sup>3</sup>.

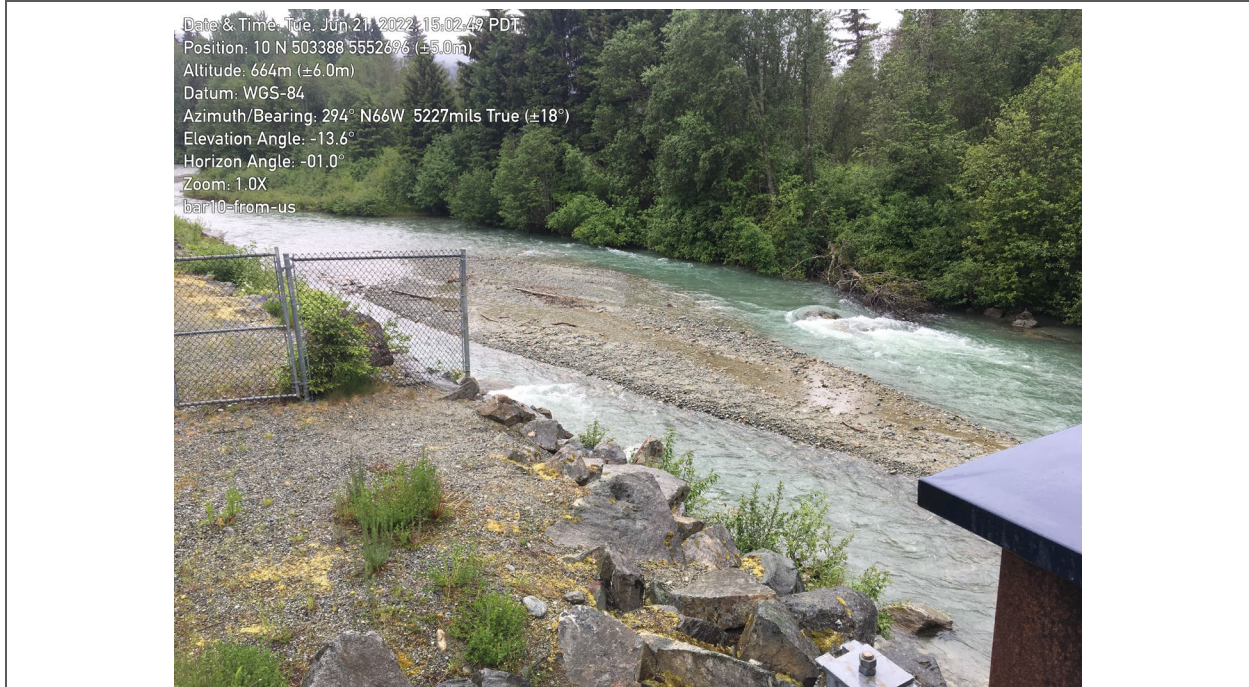
**Photo 6:** Gravel Bar #10 from upstream. Estimated gravel extraction volume = 764 m<sup>3</sup>.

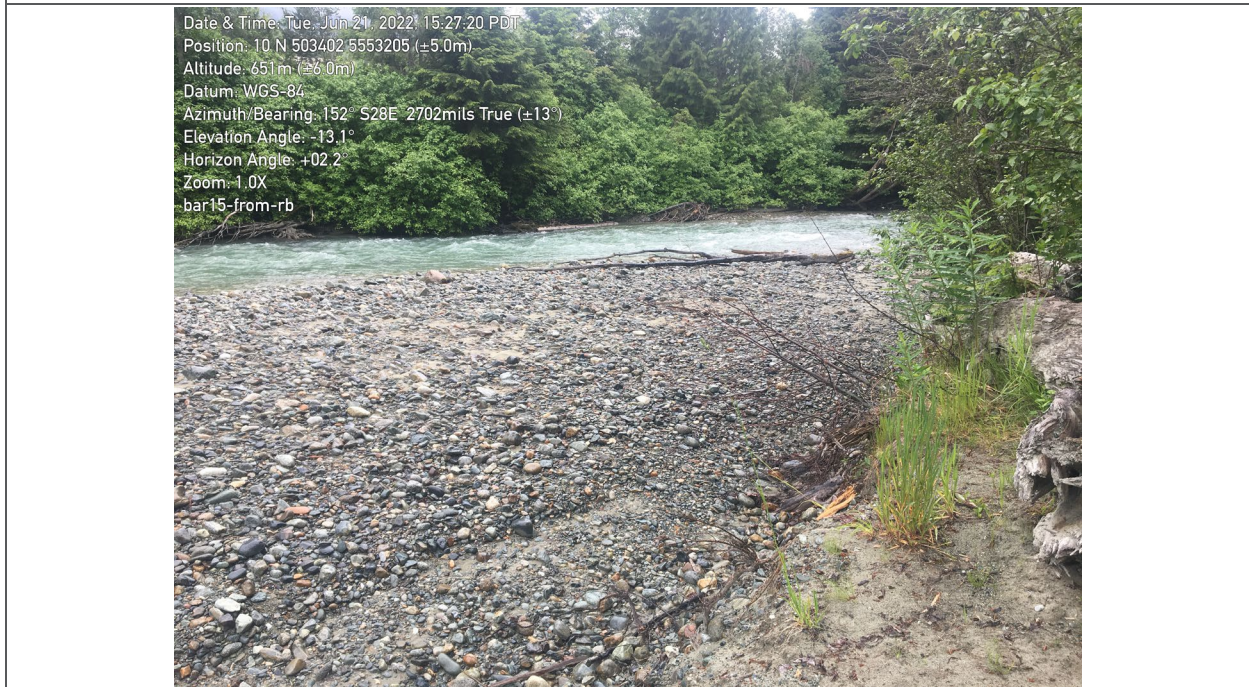
**Photo 7:** Gravel Bar #15 from right bank. Estimated gravel extraction volume = 2,669 m<sup>3</sup>.

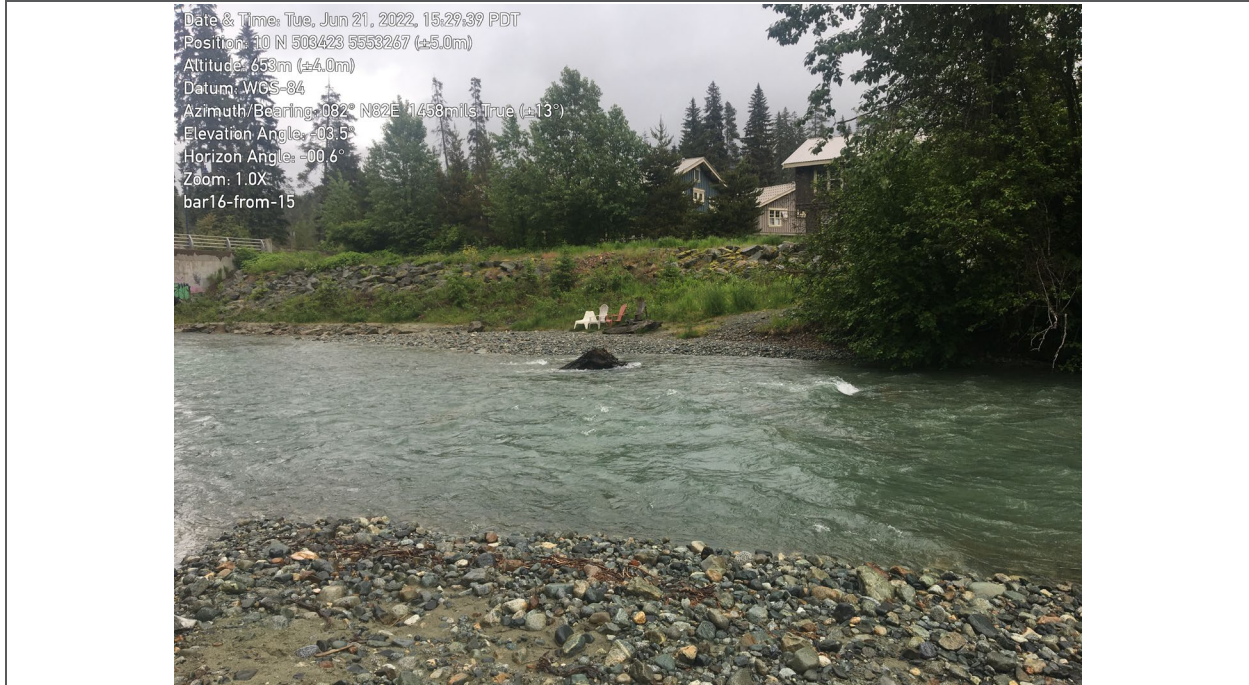
**Photo 8:** Gravel Bar #16 from bar #15. Estimated gravel extraction volume = 95 m<sup>3</sup>.

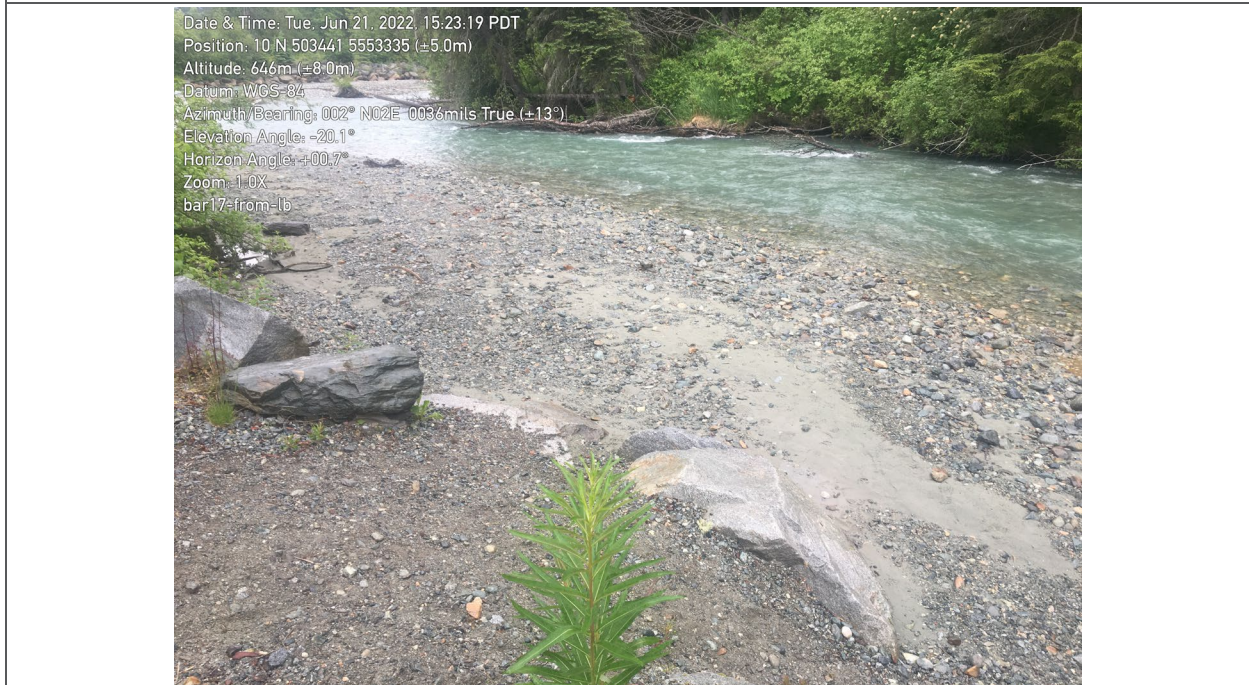
**Photo 9:** Gravel Bar #17 from left bank. Estimated gravel extraction volume = 731 m<sup>3</sup>.

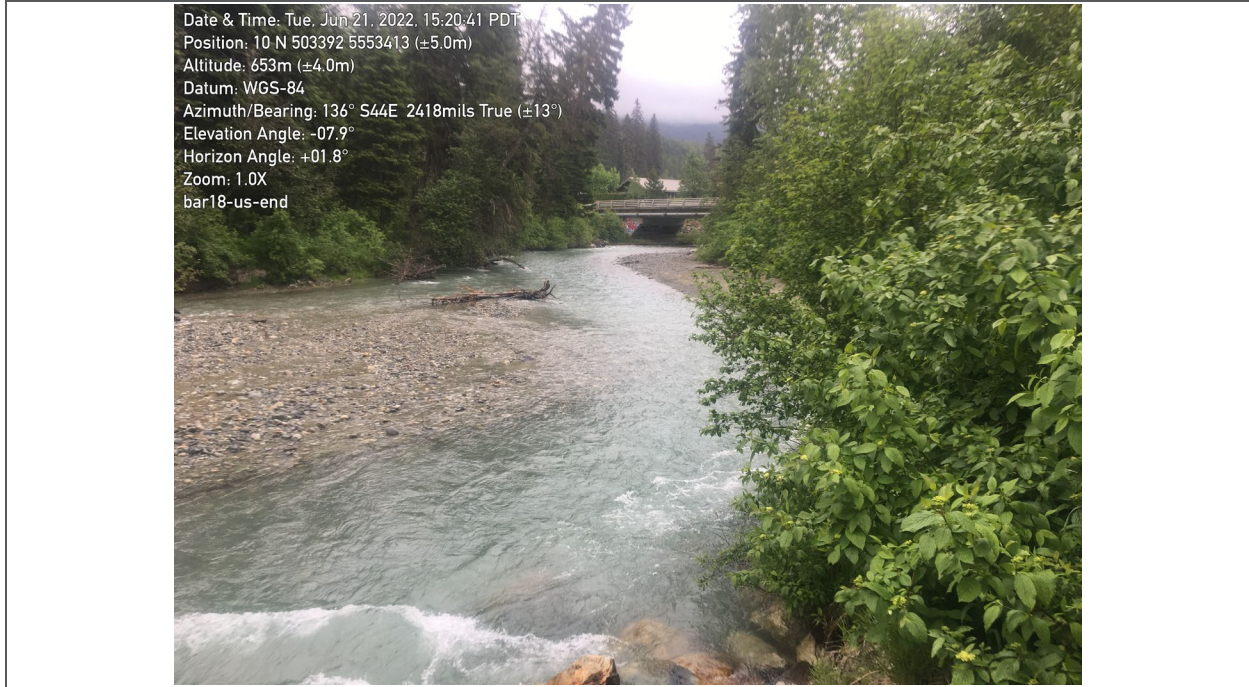
**Photo 10:** Gravel Bar #18 upstream end. Estimated gravel extraction volume = 1,516 m<sup>3</sup>.

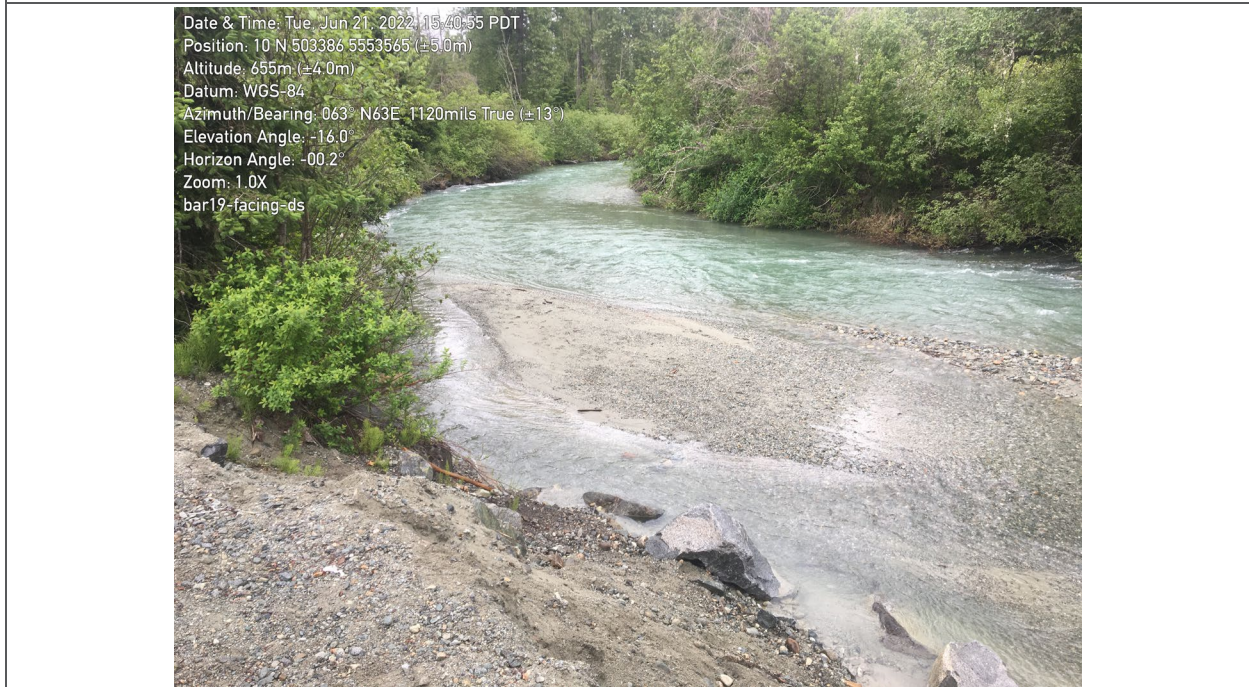
**Photo 11:** Gravel Bar #19 facing downstream. Estimated gravel extraction volume = 1,644 m<sup>3</sup>.

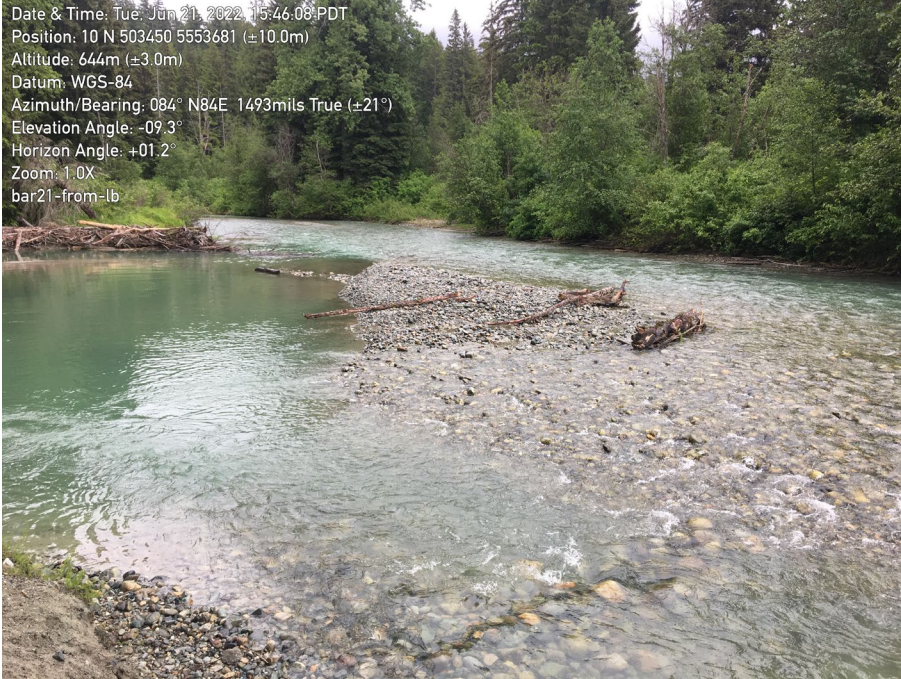
**Photo 12:** Gravel Bar #21 from left bank. Estimated gravel extraction volume = 316 m<sup>3</sup>.

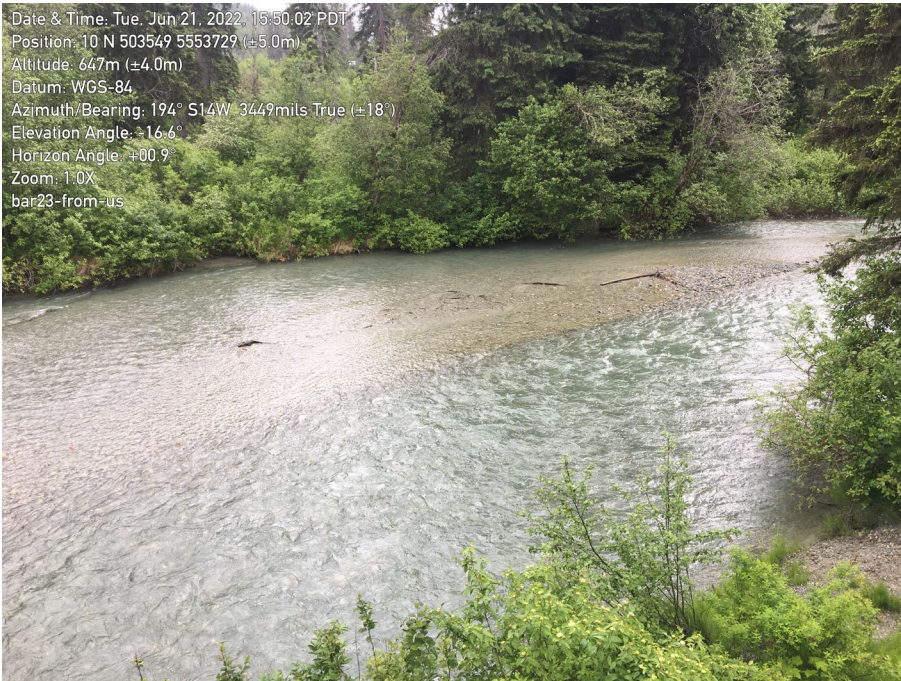
**Photo 13:** Gravel Bar #23 from upstream. Estimated gravel extraction volume = 444 m<sup>3</sup>.

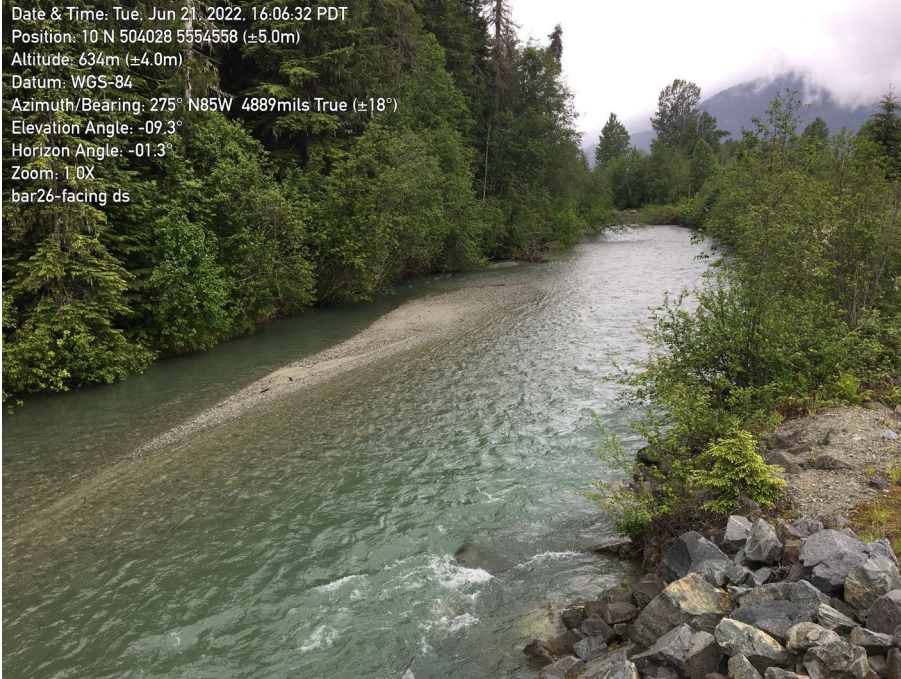
**Photo 14:** Gravel Bar #26 facing downstream. Estimated gravel extraction volume = 519 m<sup>3</sup>.

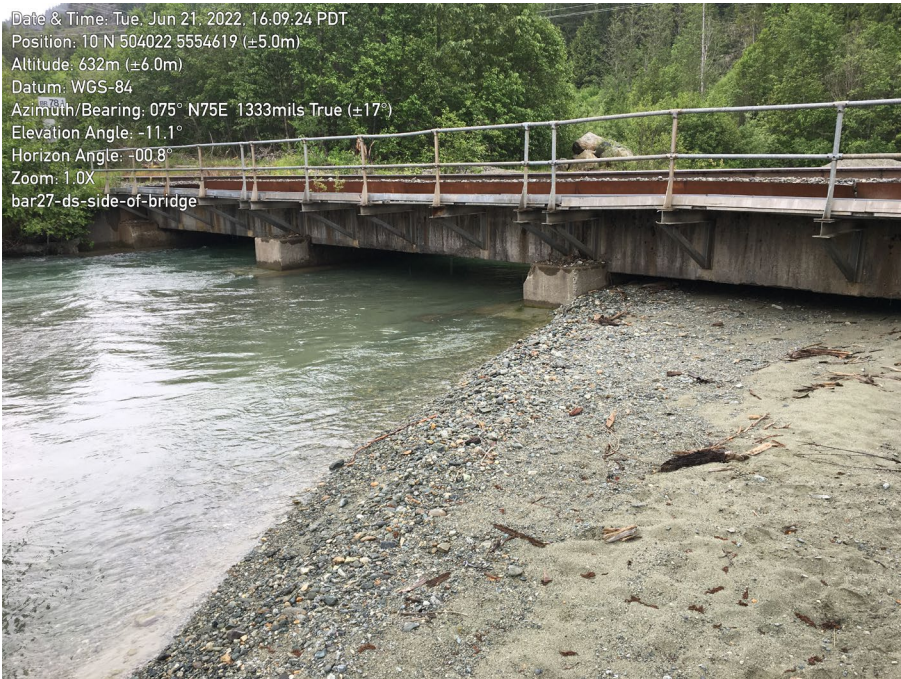
**Photo 15:** Gravel Bar #27 downstream side of CN railway bridge. Estimated gravel extraction volume = 442 m<sup>3</sup>.

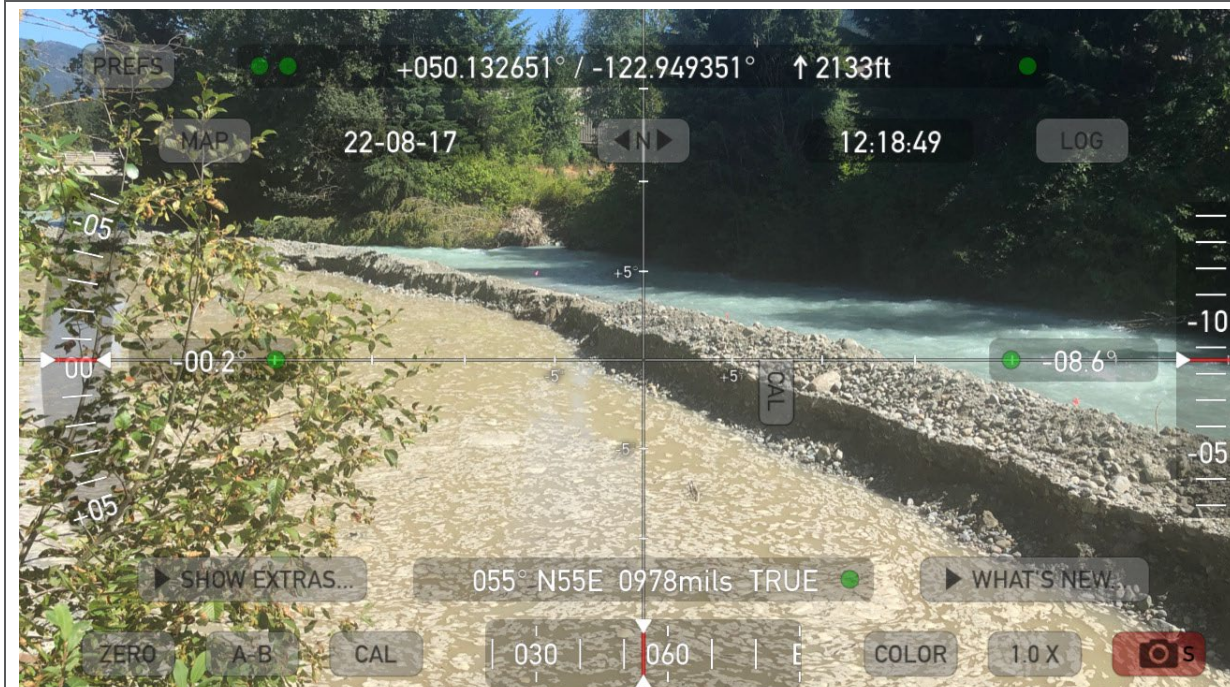
**Photo 1:** Gravel Bar #15 excavation complete – facing downstream. Berms still intact with no creek flow through excavation area.

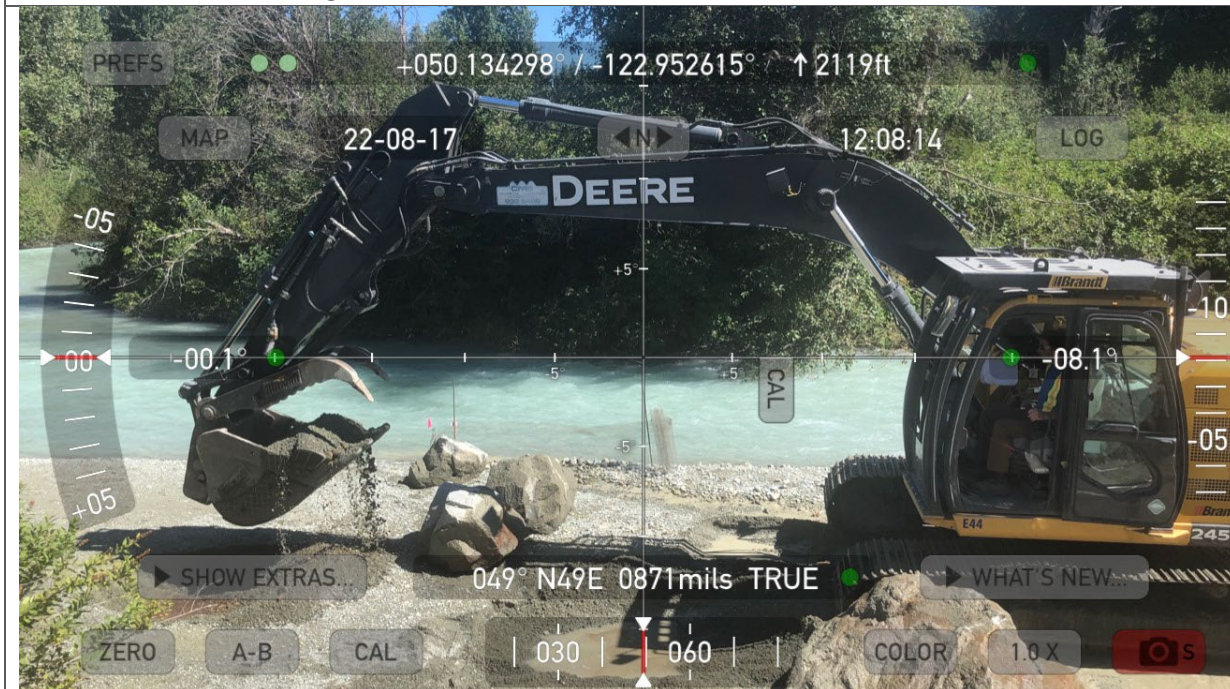
**Photo 2:** Gravel Bar #19 preparing for excavation. Fish net present for fish salvage.

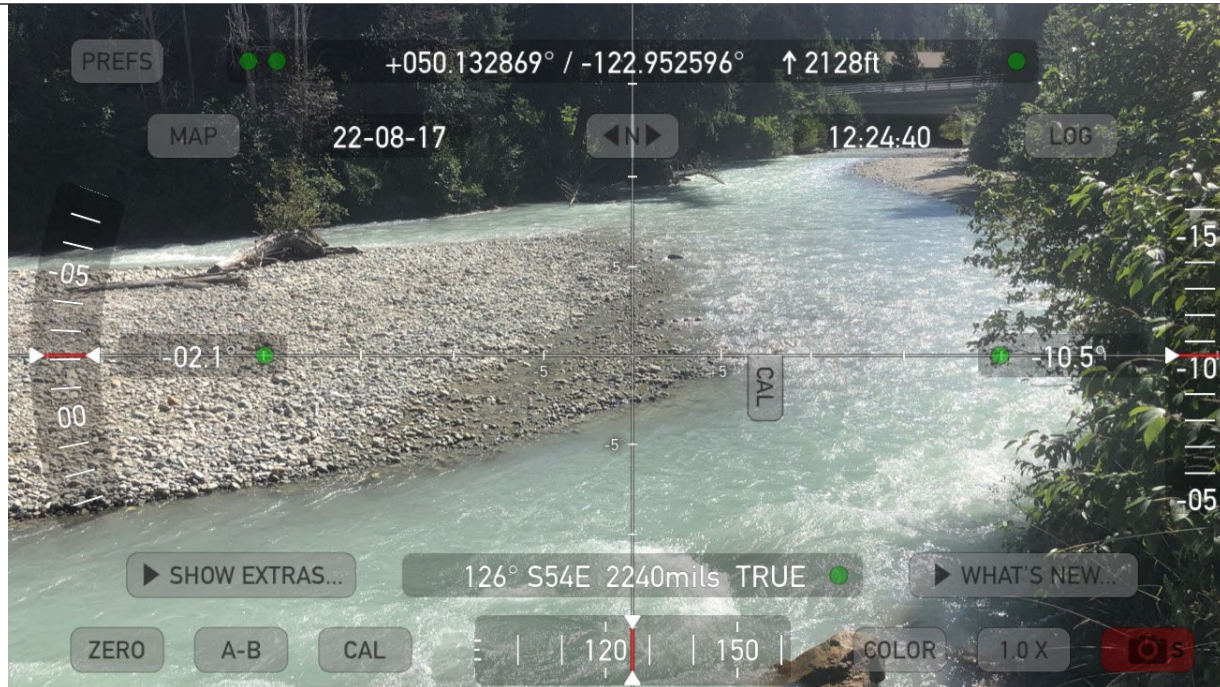
**Photo 4:** Gravel Bar #18 in foreground and Gravel Bar #17 in background. Looking upstream

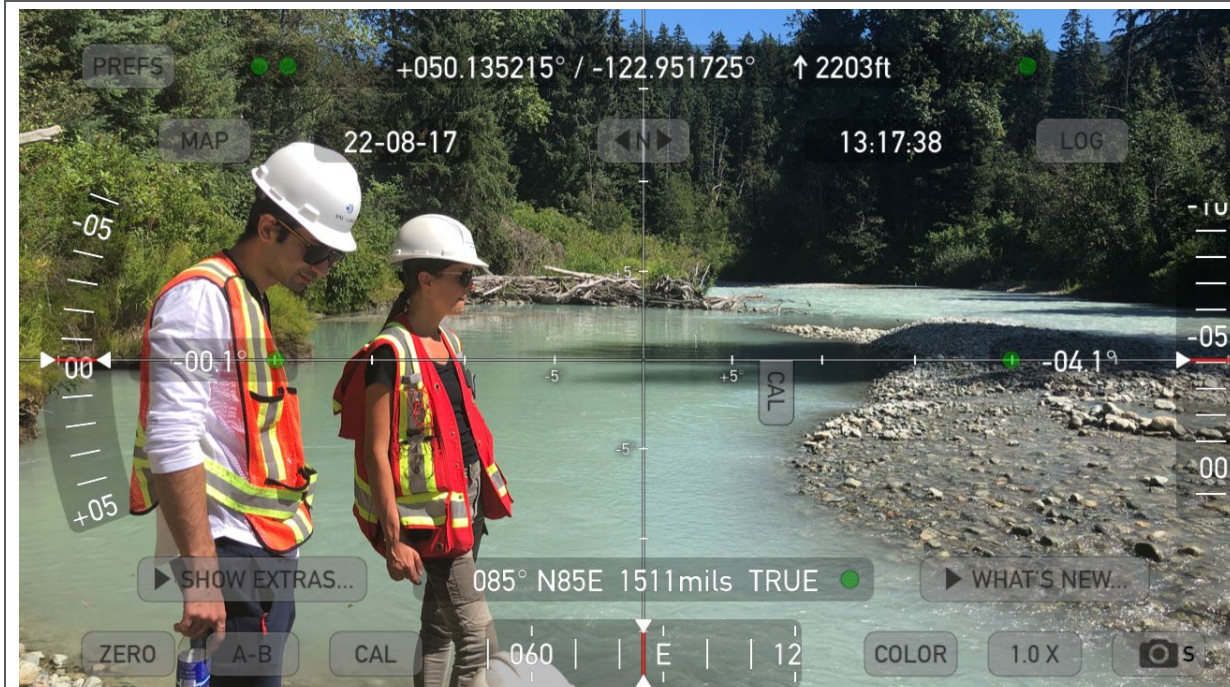
Photo 5: Downstream left bank portion of Gravel Bar #21 - planning excavation.

- **Special Note:** After the site visit Cascade Environmental requested to extract Gravel Bar #17 instead of Gravel Bar #21 due to high flows and the difficulty of maintaining fish isolation in these conditions. The project engineer approved extraction of Gravel Bar #17 instead of #21. At time of writing we are waiting for confirmation of this change by RMOW.

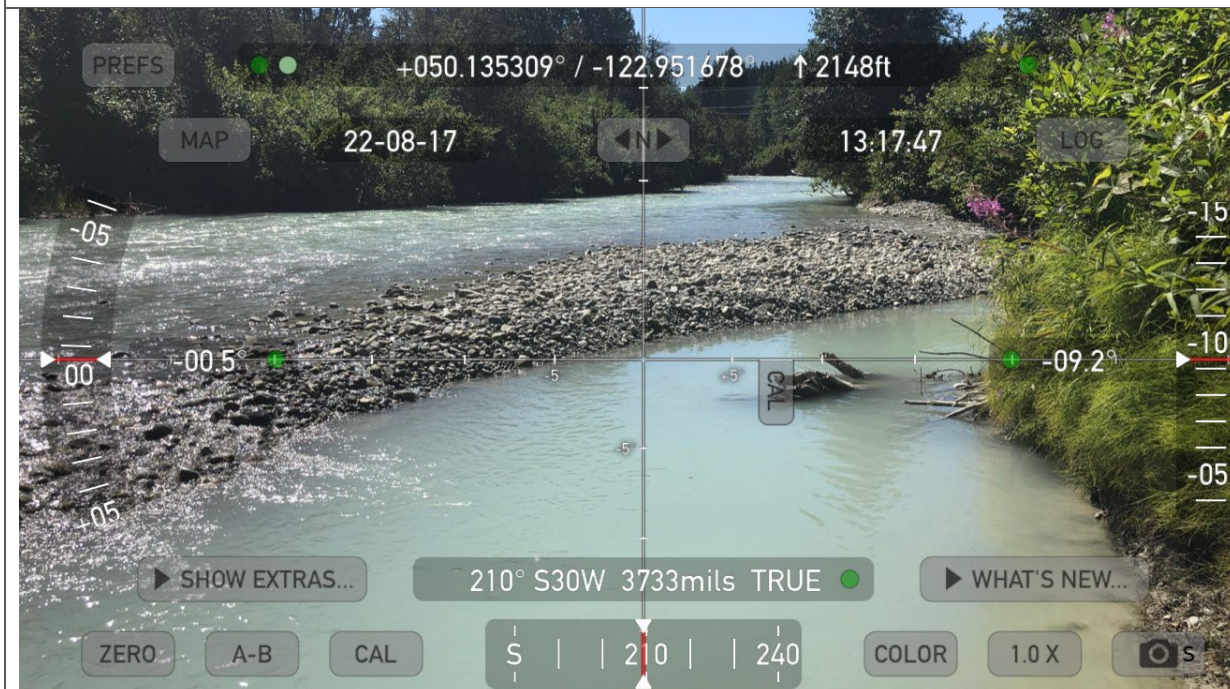
Photo 6: Upstream left bank portion of Gravel Bar #21 - planning excavation.

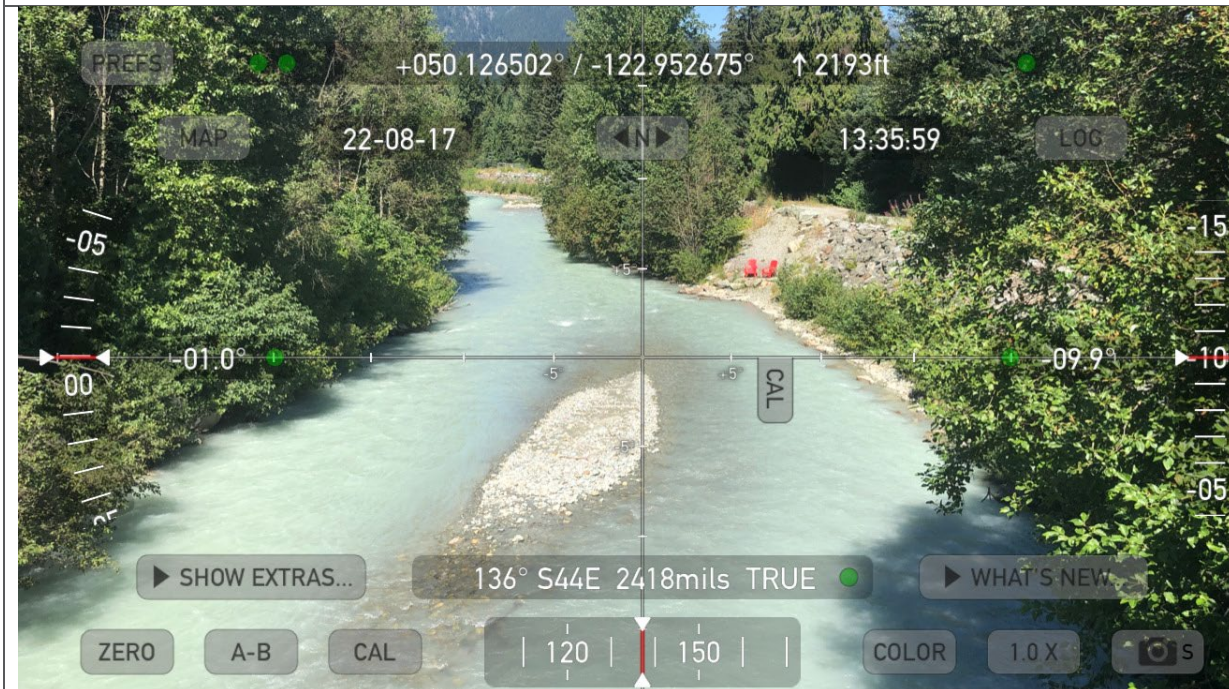
Photo 8: Gravel Bar #11 – looking downstream.

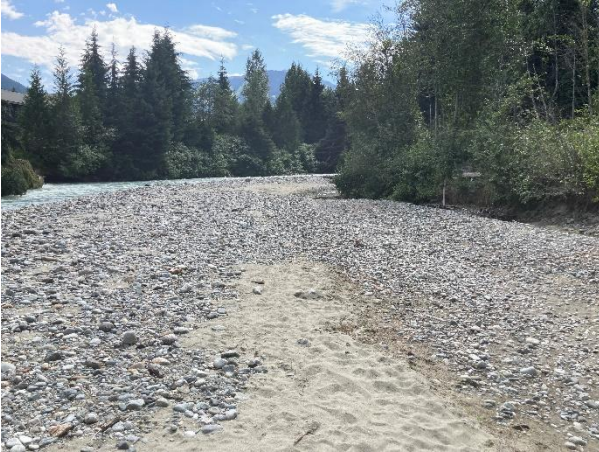
- On August 15, 2022, the side channel at Bar 15 was isolated with upstream and downstream fences.
- Following isolation, a fish salvage was carried out using minnow trapping and electrofishing methods. Details of these methods and the results of the fish salvage are found in Table 3 in Appendix A.
- A total of 3 fish were salvaged including: 1 bull trout (*Salvelinus confluentus*) and 2 prickly sculpin (*Cottus asper*).

**Photo 1: Bar 15 side channel. August 12, 2022.**

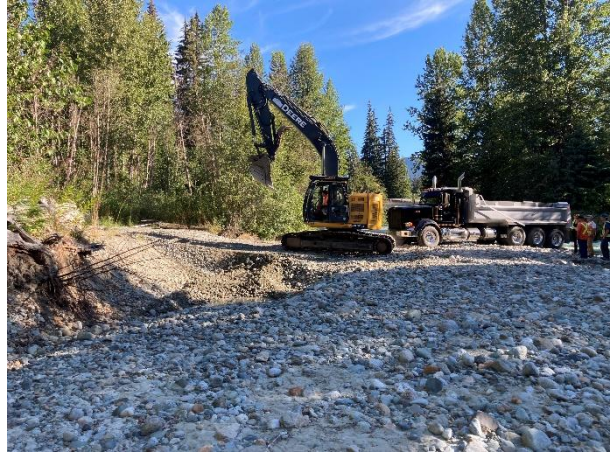
**Photo 2: Constructing a ramp for Bar 15 access from Valley Trail. August 15, 2022.**

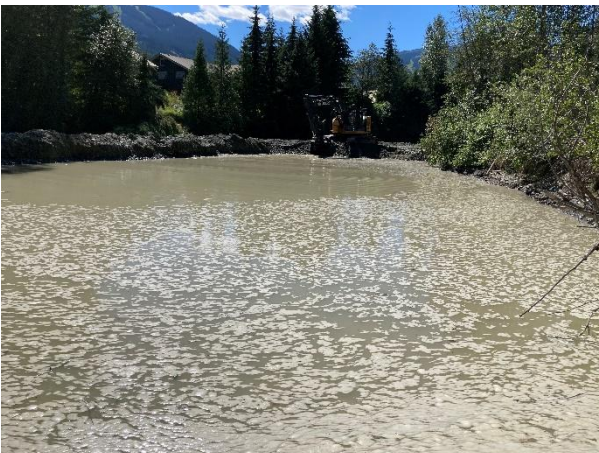
**Photo 3: Excavation of gravel on Bar 15. August 16, 2022.**

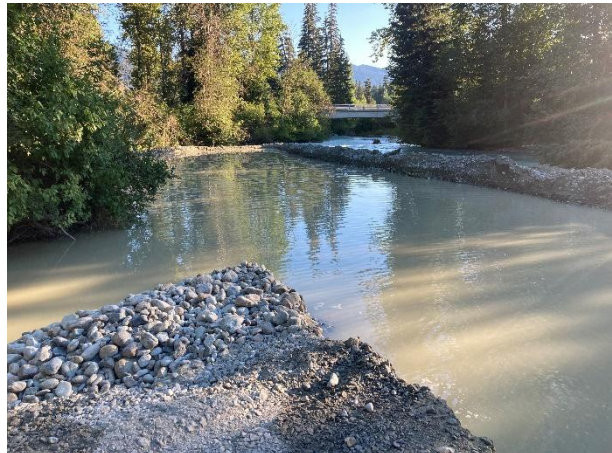
**Photo 4: View of gravel Bar 15 following the excavation. August 17, 2022.**

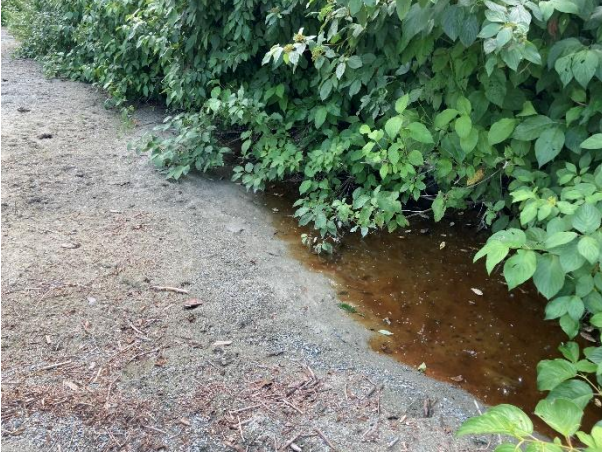
- Bar 17 contained two stagnant pools on river left that were isolated from flowing water (Photo 5). On August 22, 2022, a fish salvage was carried out using electrofishing methods. The pools were too shallow to carry out any minnow trapping. Details of electrofishing methods are found in Table 4 in Appendix A.
- No fish were salvaged from Bar 17.

**Photo 5:** View of one of the small, stagnant pools on river left of Bar 17. August 9, 2022.

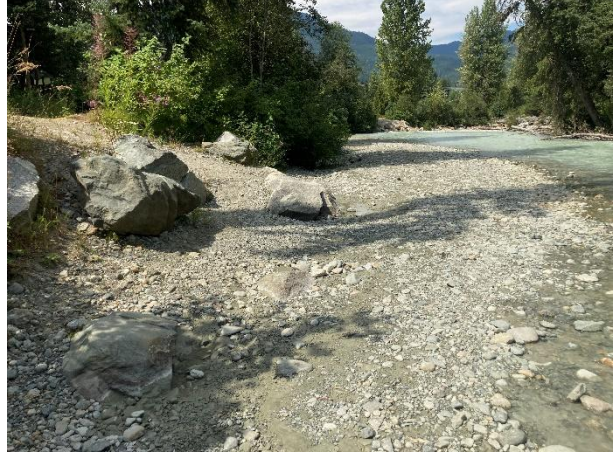
**Photo 6:** View of the downstream end of Bar 17 and access ramp, looking north. August 18, 2022.

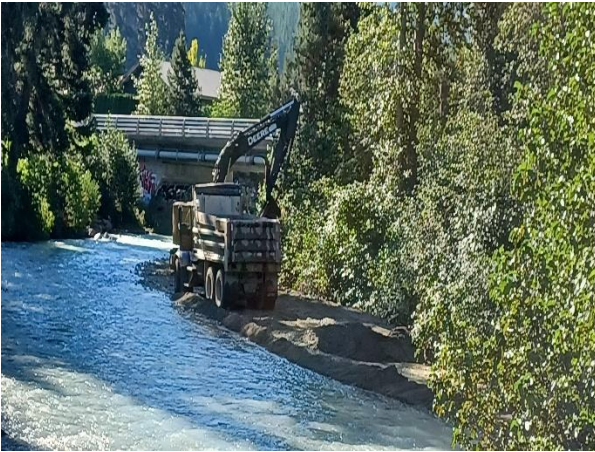
**Photo 7:** Excavation of Bar 17. August 22, 2022.

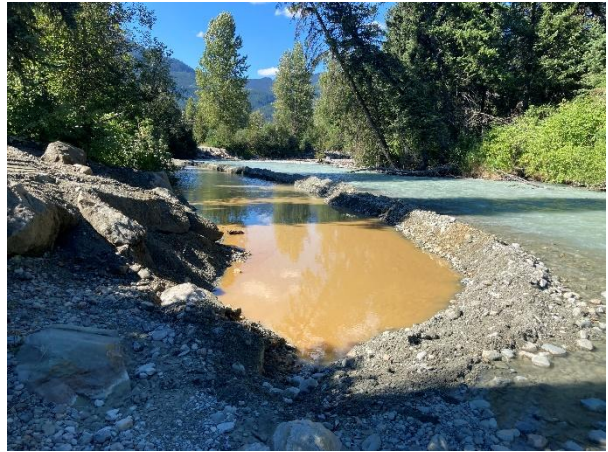
**Photo 8:** Looking north at the access ramp and constructed berm of Bar 17. August 22, 2022.

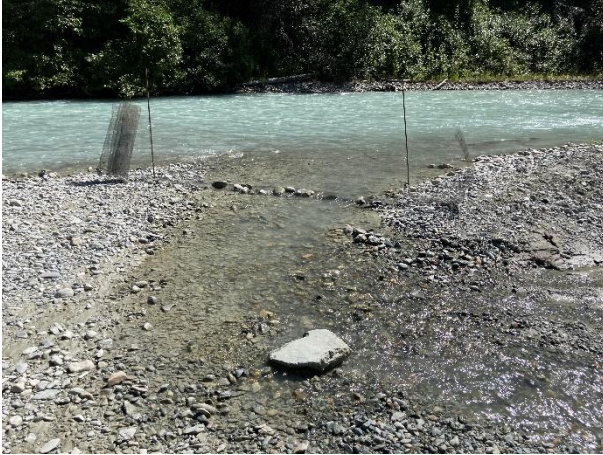
- Fish exclusion fencing was installed at the upstream and downstream ends of the side channel on Bar 19 (Photo 9).
- A fish salvage was carried out on August 16, 2022 using minnow trapping and electrofishing methods. Details of electrofishing methods and the results of the fish salvage are found in Table 5 in Appendix A.
- Following the fish salvage on August 16, 2022, the excavator operator made a wet crossing of the side channel (within the fish exclusion fencing) and a berm was constructed to isolate the bar from stream flows.
- A total of 46 fish were salvaged including: 2 bull trout, 13 rainbow trout (*Oncorhynchus mykiss*), 3 threespine stickleback (*Gasterosteus aculeatus*) and 28 prickly sculpin.

**Photo 9: Installation of fish exclusion fencing at Bar 18. August 16, 2022.**

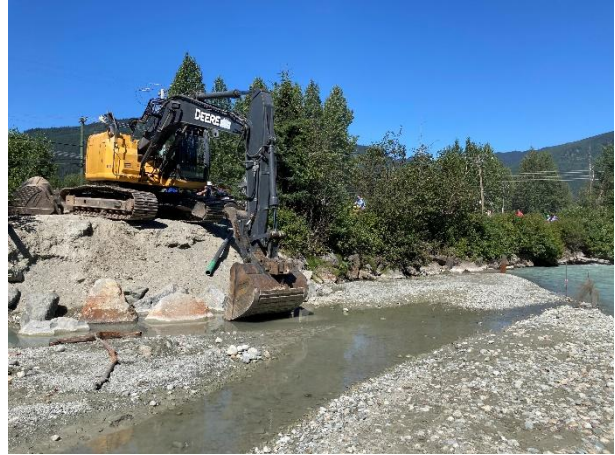
- Bar 19 was accessed from an existing un-vegetated access ramp from top of bank on river right east of Mons Road (Photo 9 and Photo 10). Site works were conducted over a three-day period from August 17 to 19, 2022 (Photo 10 to Photo 12).
- The Cascade Environmental Monitor noted a hydrocarbon leak from the excavator after works were complete at 15:40 on August 18, 2022. The contractor advised the EM that the excavator operator had over-filled the fuel tank and an estimated 125 ml of diesel fuel leaked to ground beneath the machine. The machine was cleaned and all contaminated soil excavated by hand and removed off-site for disposal by GFL Environmental Inc. prior to initiating works the following day (August 19, 2022). No hydrocarbons entered Fitzsimmons Creek as a result of the spill.

**Photo 10: Excavator operator preparing the Bar 18 access ramp. August 17, 2022.**

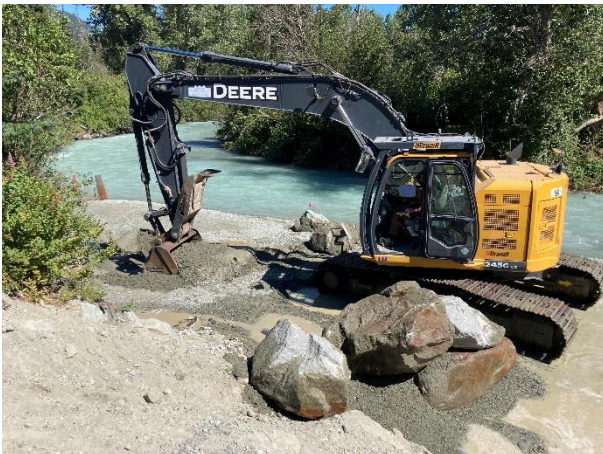
**Photo 11: Gravel extraction from Bar 18. August 17, 2022.**

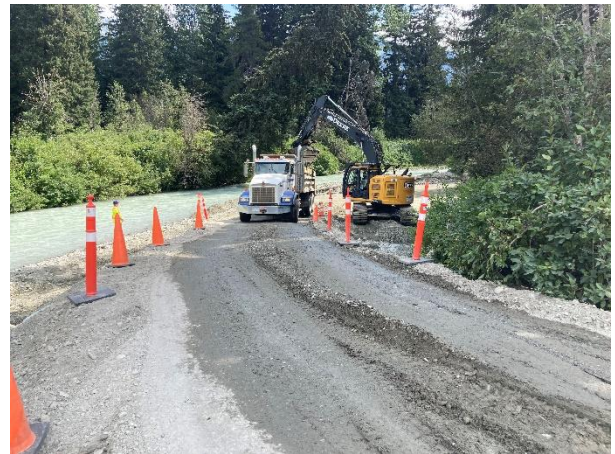
**Photo 12: Gravel extraction from Bar 18. August 18, 2022.**
