Water Utility Infrastructure Rehabilitation Study

Resort Municipality of Whistler
4325 Blackcomb Way
Whistler, BC V0N 1B4

March 18, 2014

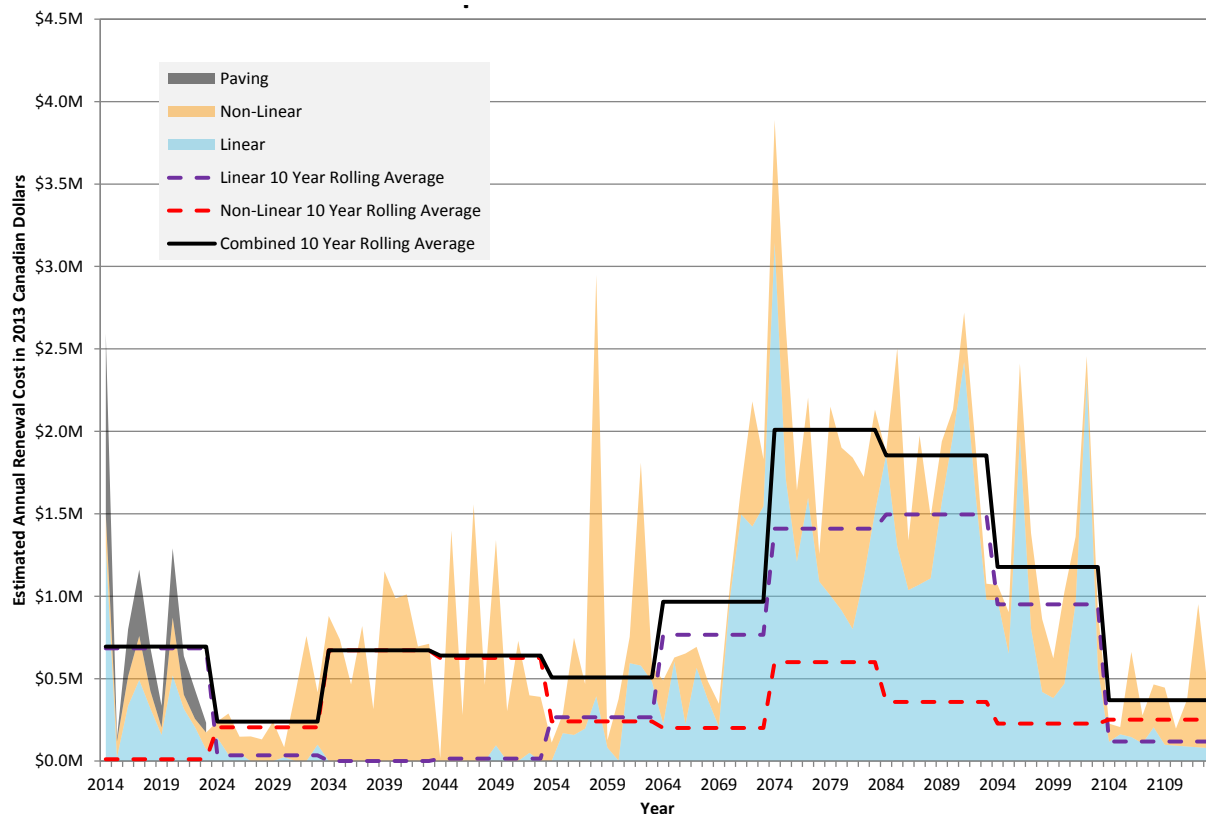
Figure ES.1: 100 Year Renewal Budget Estimates

Figure ES.1 below shows the RMoW water system’s projected renewal requirements over the next 100 years in 2014 dollars as well as a rolling 10 year average annual cost to renew the system as individual assets approach the end of their expected service life.

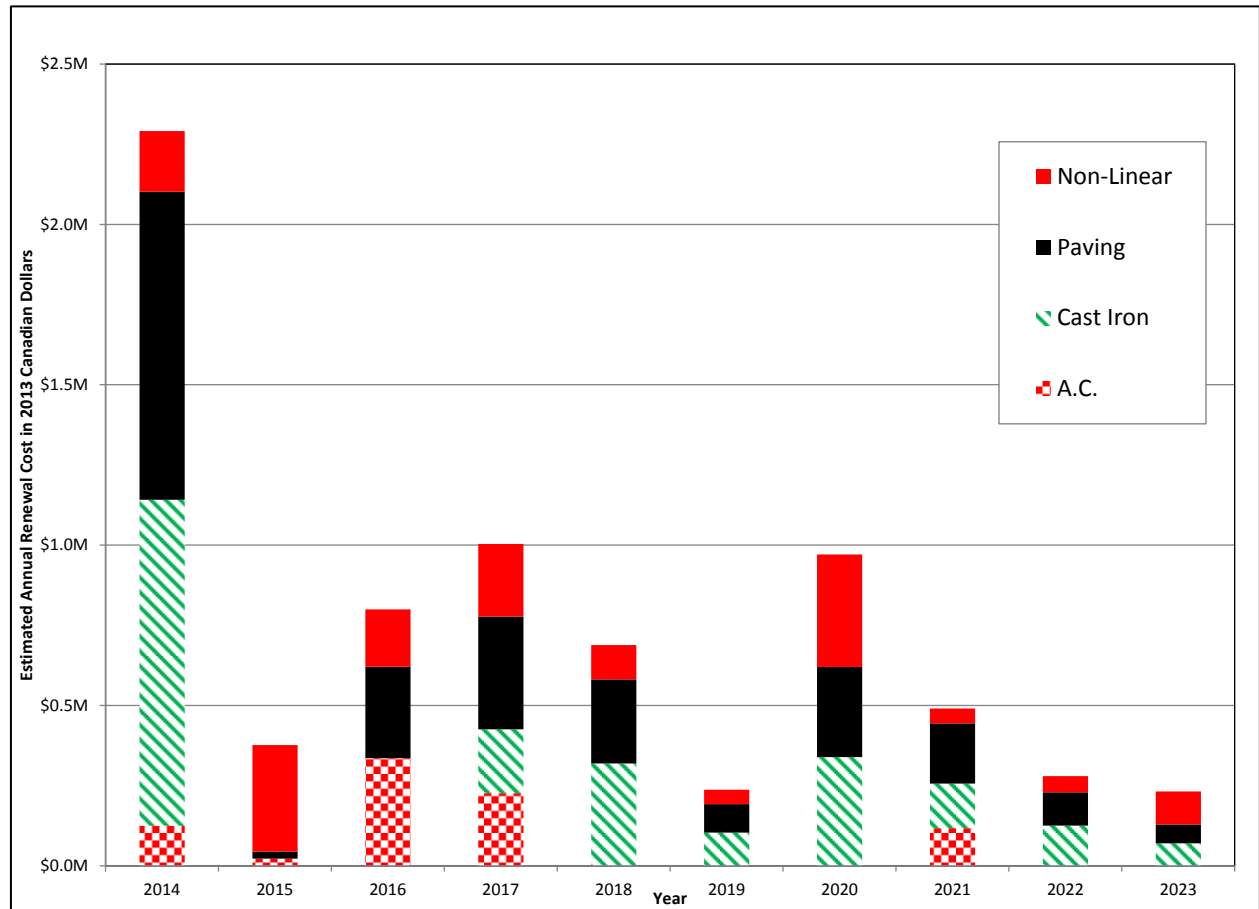
Figure ES.2: 10 Year Renewal Budget Estimates

Figure ES.2 shows the estimated capital replacement program for the next 10 years where the immediate emphasis is directed at replacing the older asbestos cement and cast iron water mains. These water main inventories are now showing evidence of deterioration. A proactive replacement program will ensure that adequate water utility levels of service can be effectively delivered to these service areas.

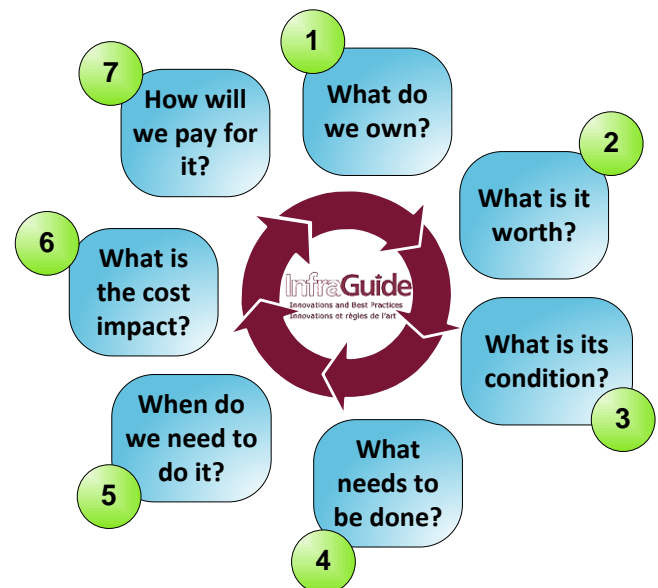
Figure 1-1: The InfraGuide "7 Questions"

AECOM applied the methodology that was published in 2007 by the National Guide for Sustainable Municipal Infrastructure's (InfraGuide) "Best Practice for Developing a Water Distribution System Renewal Plan" as a basis for conducting this study. This methodology can be generally described by answering the "7 Questions of Asset Management" in an organized and sequenced manner (as shown in [Figure 1-1](#)). The questions are addressed through two complementary assessments: top-down and bottom-up. These two assessments differ in the detail needed for preparation and how the results can be applied.

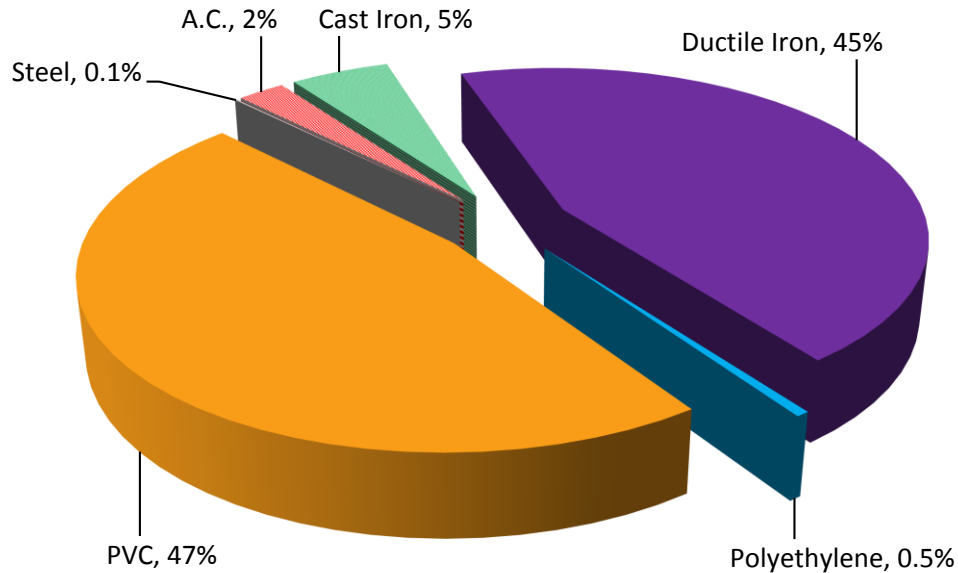
Figure 2-1: Breakdown of Water Main Inventory Length by Material

The percentage breakdown of the inventory detailed in **Table 2-1** is graphically represented in **Figure 2-1**.

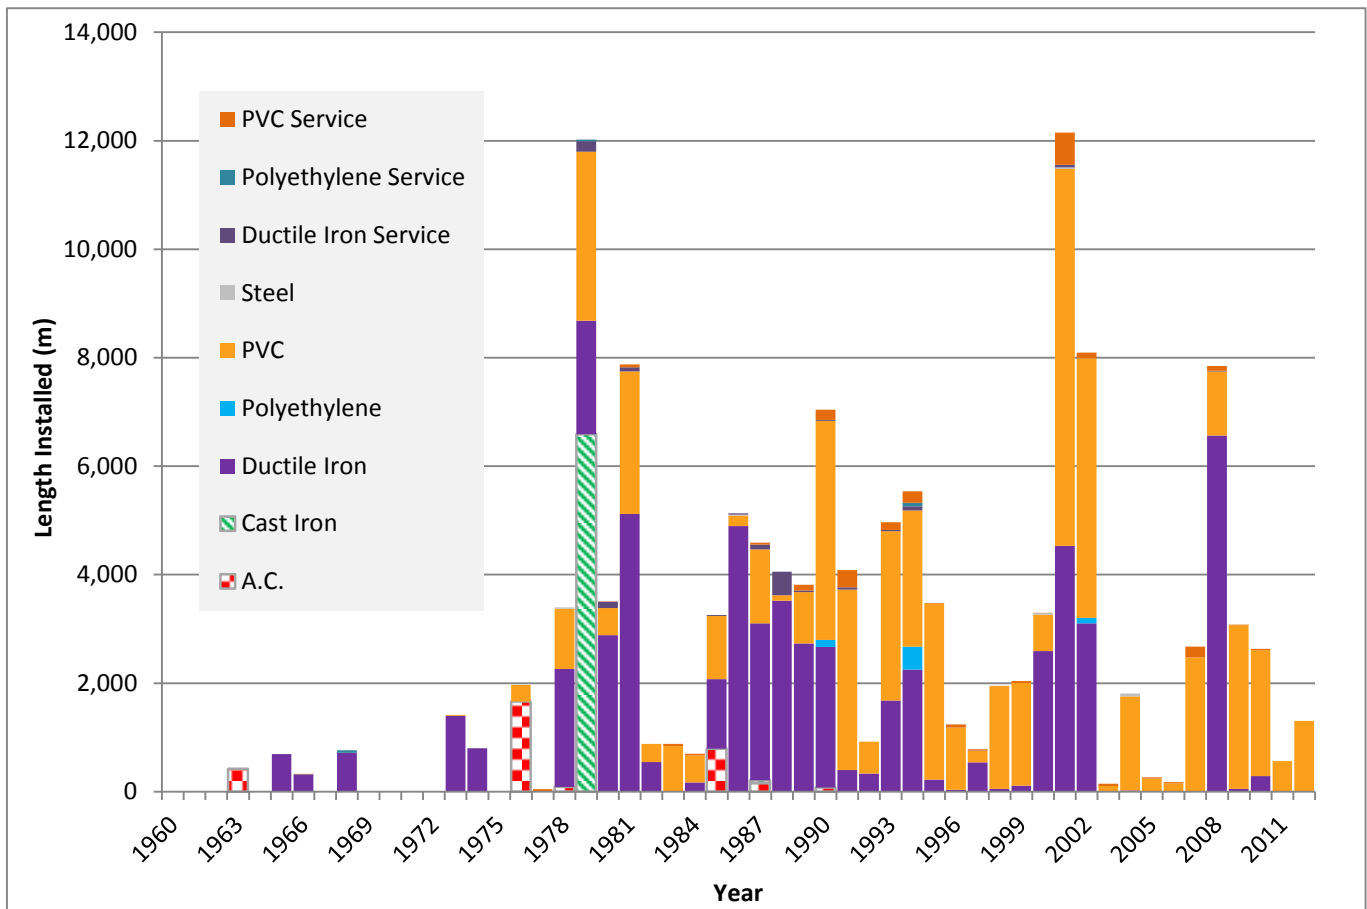
Figure 2-2: Historical Length of Pipe Installed by Material

Since the objective is to estimate when the pipes will need to be replaced, it is crucial to obtain an understanding of the particular blend of pipe age and material that constitute the RMoW water distribution piping system. The bar chart in [Figure 2-2](#) presents the historical installation profile of the piping inventory by pipe material, length, and year of installation. This will form the base from which it will be possible to begin making renewal forecasts.

The shape of the graph reflects RMoW growth being driven by periodic surges in development. It is expected that renewal of pipes will reflect this growth pattern. The majority of existing pipe was installed after 1978, and is thus less than 35 years old; this is relatively young compared to most other Canadian municipalities. The oldest mains are asbestos-cement at 50 years old. The inventory of cast iron pipe was primarily installed in 1979 and 1980, with a small installation in 1997. The majority of the pipe inventory has been PVC and ductile iron, with no clear trend in either pipe material use - it appears that use of PVC or ductile iron is based on cost of material and/or developer preference. The small population of steel and polyethylene pipes appear to have been installed in one-off projects as needed.

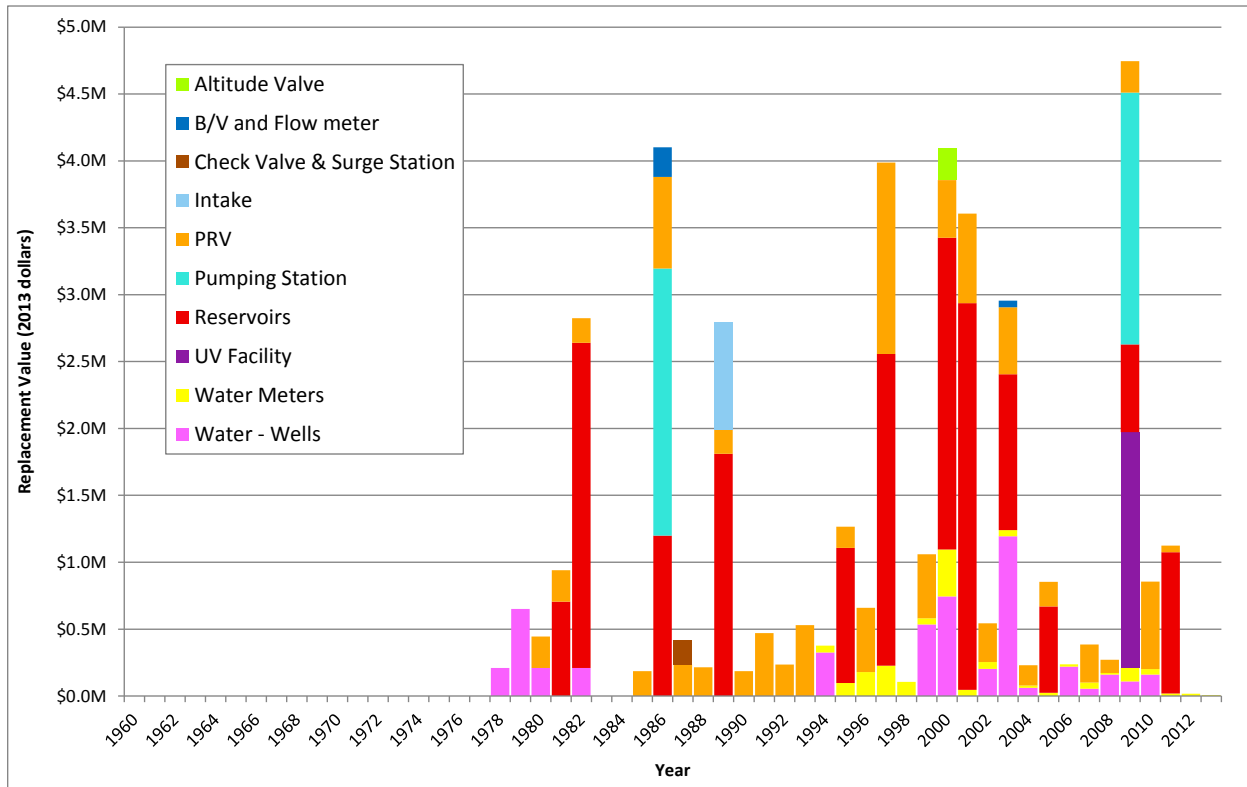
Figure 2-3: Historical Installed Cost of Non-linear Assets

With regards to the existing non-linear water distribution infrastructure the historical dates of construction and installation is presented in terms of 2014 replacement value in [Figure 2-3](#).

The growth of the non-linear infrastructure appears to lag the pipe network, likely because of the shorter lives of the non-linear assets. However, the overall pattern of growth reflects the expansion of the pipe network and Whistlers periodic development episodes.

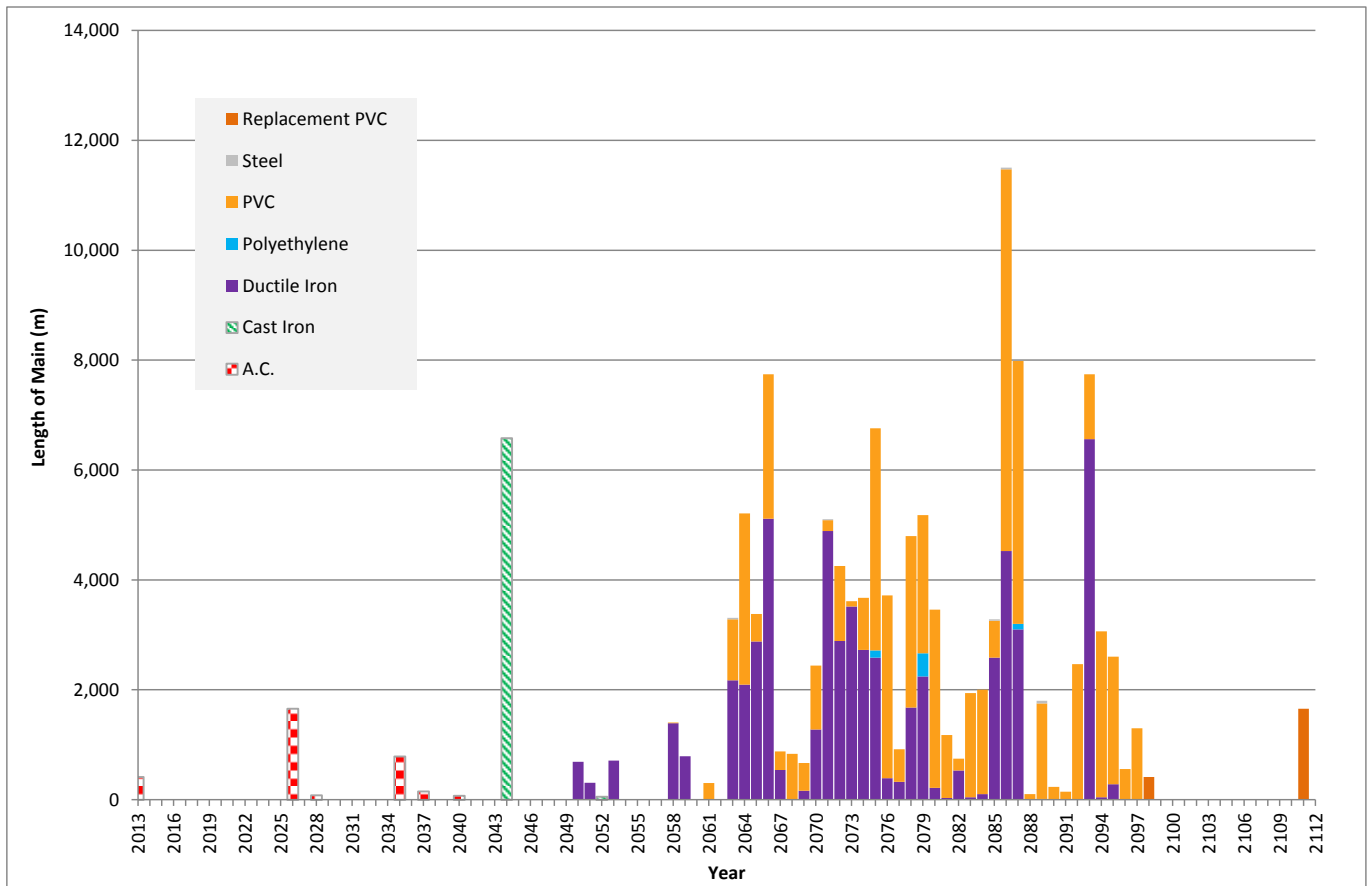
Figure 2-4: Forecast of Water Main Replacements Based Only on Expected Service Life

Using only the expected service life estimates in [Table 2-10](#) to forecast when individual water mains will need to be replaced, the following graph provides a projection of the next 100 years of water main replacements.

Figure 2-4 assumes that each water main will need to be replaced at exactly the end of its expected service life, which we know is unlikely. Some water main lengths will last longer and some will be in need of replacement sooner. To simulate this we used the Weibull probability distribution to model a replacement envelope and predict a water main length failure range. To quantify variation in degradation rates in pipelines, the Weibull Probability Density Function (PDF) has previously proven useful^{1,2}. The Weibull distribution has been used extensively in reliability studies and lifetime prediction models in industries ranging from automotive to oil and gas. A further discussion of the Weibull Probability Distribution is provided in [Appendix C](#).

It is assumed that failures will occur as the pipe ages in a statistical Weibull distribution³. Applying this method to the length of main to be replaced for each pipe material and overlaying it on the replacement based on ESL of [Figure 2-4](#) yields the output presented in [Figure 2-5](#).

The forecast estimated linear asset works shows an aggressive replacement program for the A.C. and cast iron water main inventories in the near future (within the next 10 years), followed by a period of about 30 years where very little water main replacement is forecast. Compared with [Figure 2-4](#) the bottom up assessment has significantly brought forward the replacement of the high risk A.C and cast iron water mains. The need to rehabilitate/renew the remaining network is not forecasted to begin until 2053, and it progressively increases to a peak of approximately 7.9 km in 2074. We have assumed that 20 mm services are replaced with the water mains, and their costs are directly included in the replacement estimate of the main.

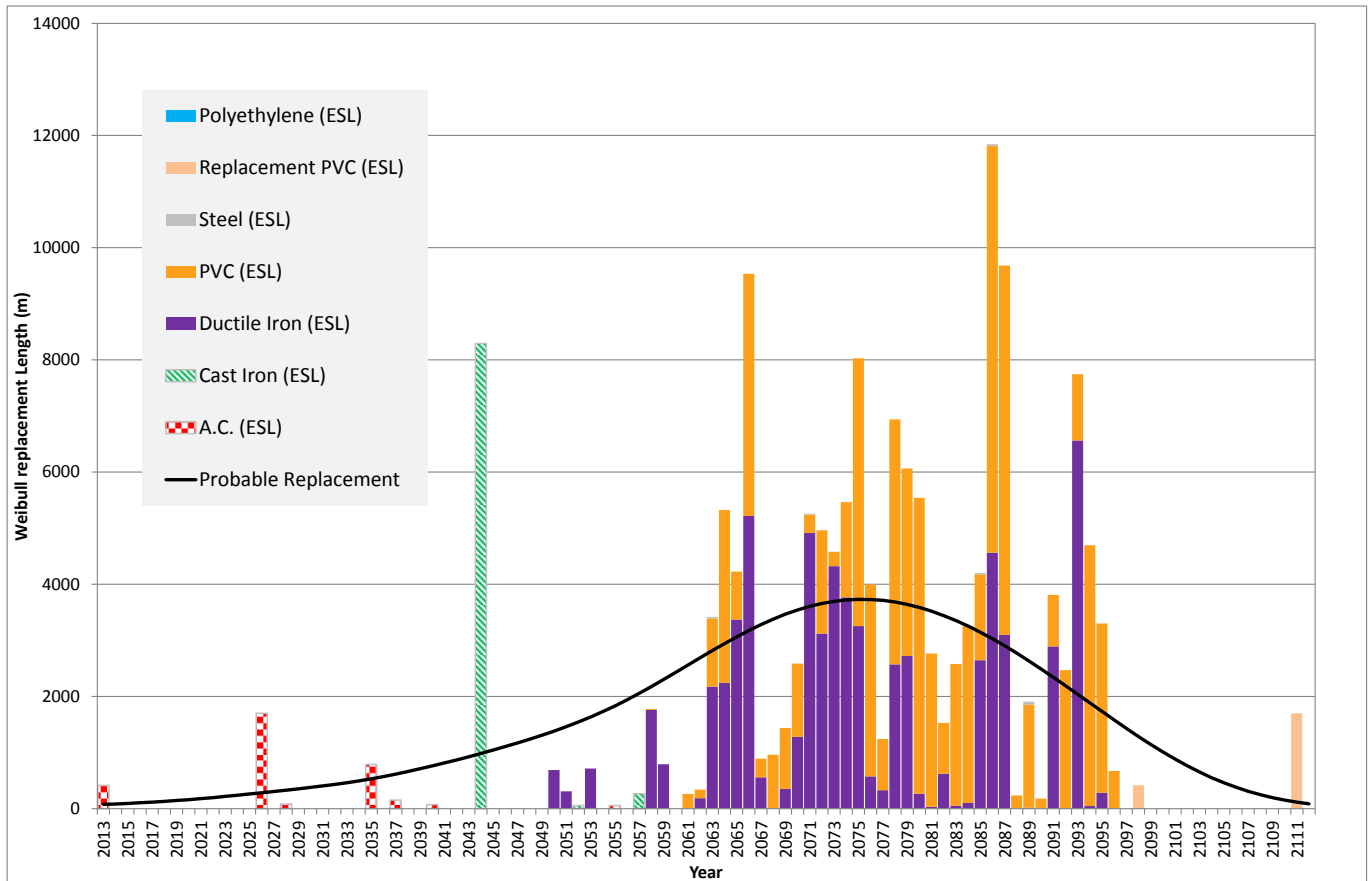
Figure 2-5: Water Main Expected Replacement Length by Year, Adjusted for Variability

³ With a shape parameter of 8, and a scale parameter according to the expected life of the pipe.

Figure 2-5 shows the expected replacement requirements for each pipe material, and the Weibull Probability Distribution applied to these replacements. It can be seen how applying the Weibull Probability Distribution smooths out the lengths of mains to be replaced. The Weibull predicted replacement shows a fairly low and steady rate of anticipated renewal requirements for the next 20 years and a rapid rise in the need for water main replacements there after. The hump is predicted to occur around 2075, coinciding with the peak replacement for the large inventory of PVC and ductile iron mains that were installed from 1980 to 2010.

This type of replacement curve is sometimes referred to as the “Nessie Curve” (AwwaRF, 2001) and reflects the periods where the system underwent significant growth. The RMoW differs from most municipal water systems in Canada due to its later stage of development.

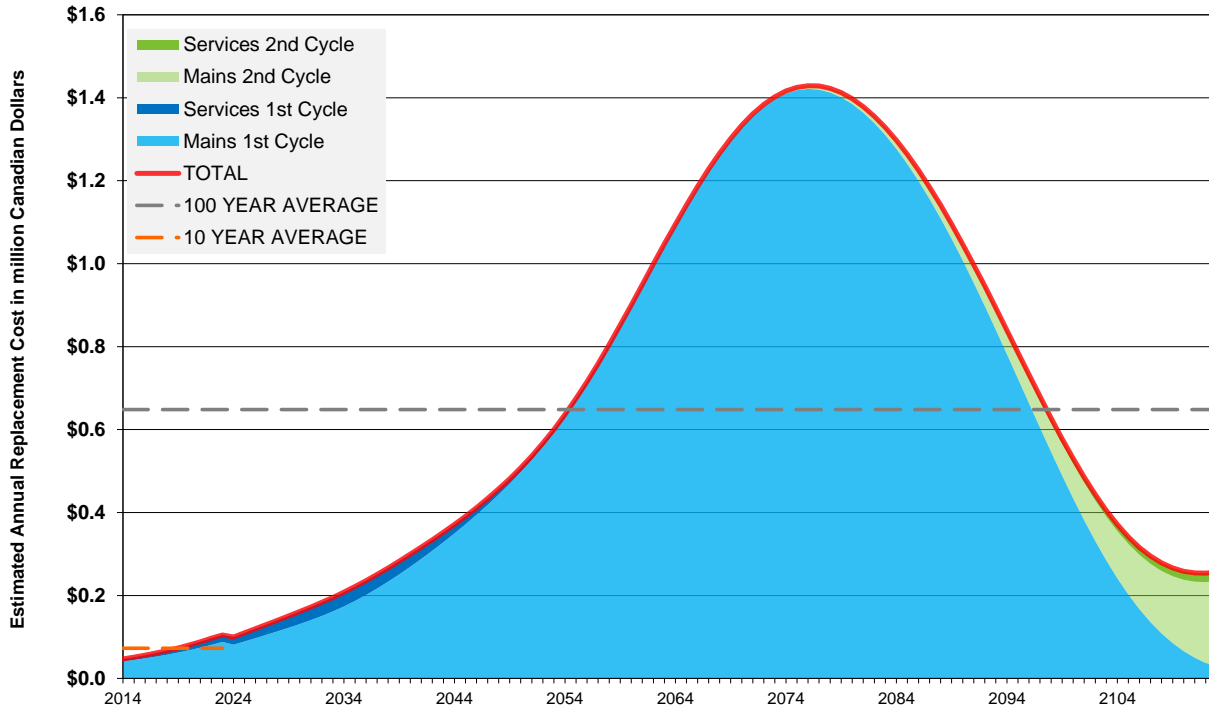
Figure 2-6: Top-down Forecast Expenditure for Water Main & Service Replacement over the next 100-years

Looking at the longer term, the top-down analysis for the linear assets forecasts the cumulated replacement expenditure to be approximately \$ 64,800,000 for the next 100 years to 2112, with an average replacement expenditure of \$ 648,000. [Figure 2-6](#) presents the 100-year forecast resulting from the top-down analysis.

Note: Unit replacement costs include engineering costs, valves and all nodal fittings such as junctions, tees, crosses, bends and ferrules. They do NOT include road resurfacing costs.

The forecast expenditure peaks in 2076 at approximately \$ 1.4 M. The forecast expenditure steadily increases for the next 30 years, then increases rapidly as the bulk of the pipe population reaches the end of its expected service life.

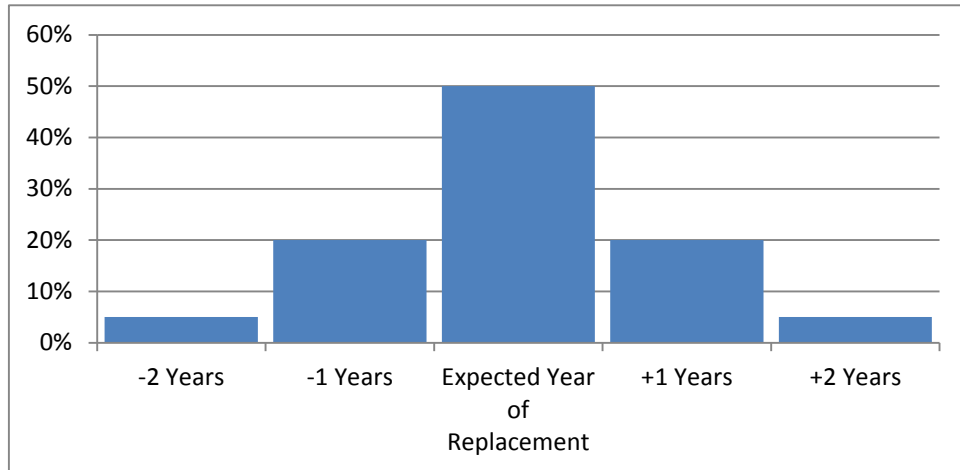
Figure 2-7: Cost Spread for Non-Linear Assets

For the non-linear assets the forecast replacement and refurbishment requirements based on expected service lives, and with an uncertainty spread over five years as per Figure 2-7, is presented in Figure 2-8.

The uncertainty spread is applied to take account of the variability of maintenance projects for fixed assets. The forecast is relatively erratic compared with the linear forecast, with required expenditures ranging from \$ 19,500 up to \$ 1.15 M in 2089. The repeating pattern of the renewal works can be seen clearly with the shorter lived non-linear assets.

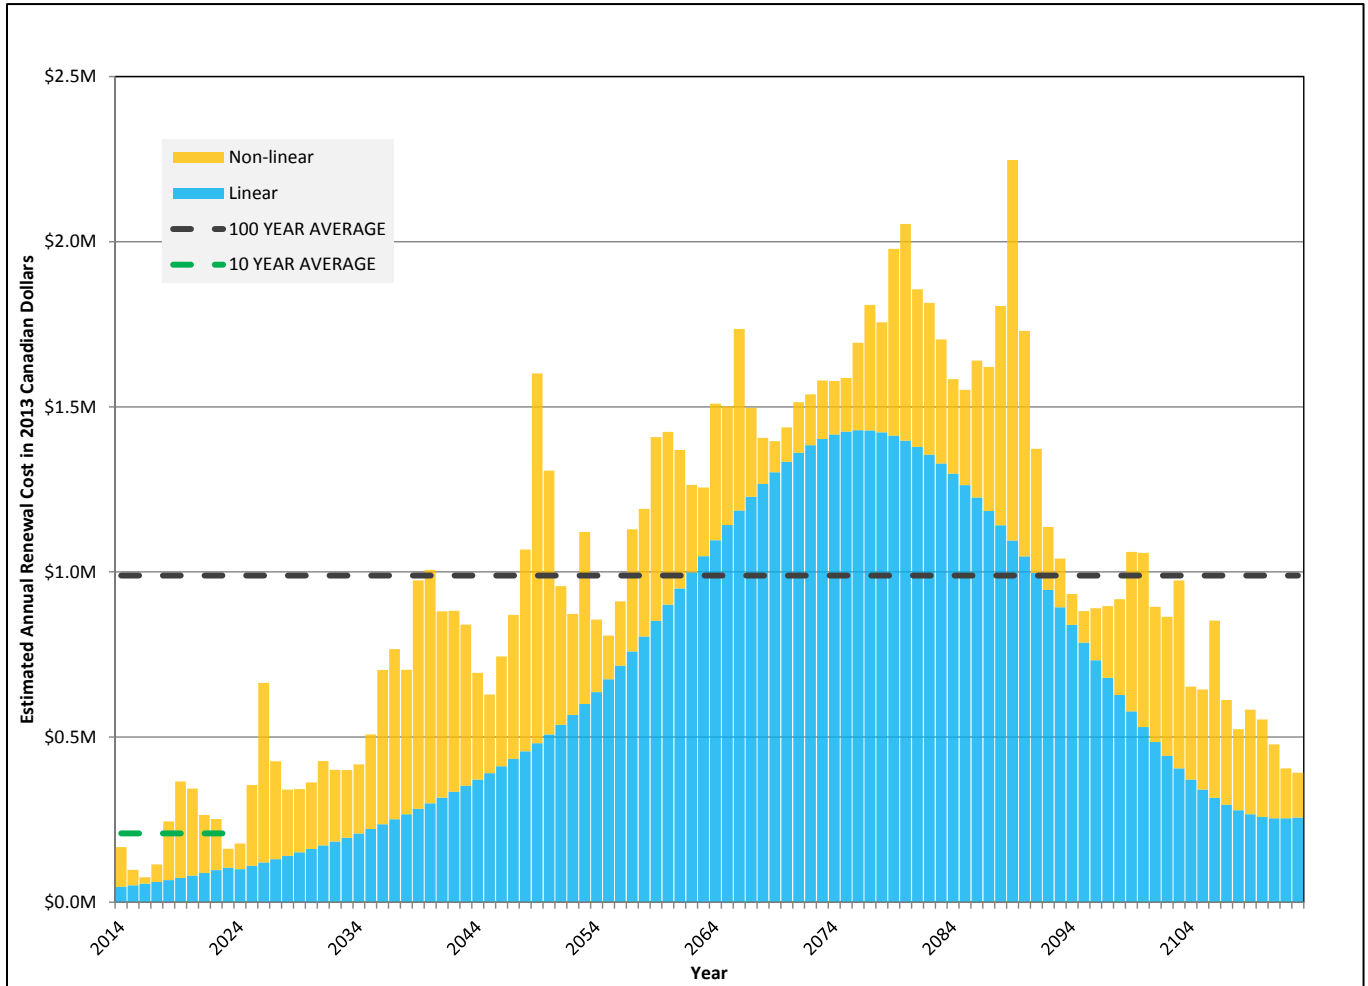
Figure 2-9: Combined Linear and Non-Linear 100 Year Forecast Renewal Costs

We can combine the 100-year forecast renewal for the linear and the non-linear water distribution assets to produce the chart presented in [Figure 2-9 \(following\)](#). When combined the 100 year cumulated expenditure is forecast to be approximately \$ 98 M, with an average annual renewal cost of \$ 989,000. The peak expenditure of approximately \$ 2.2 M occurs in 2089.

100 year total expenditures are forecast at \$ 98 M, with an average annual cost of \$ 989,000. The forecast peak expenditure of approximately \$ 2.2 M occurs in 2089.

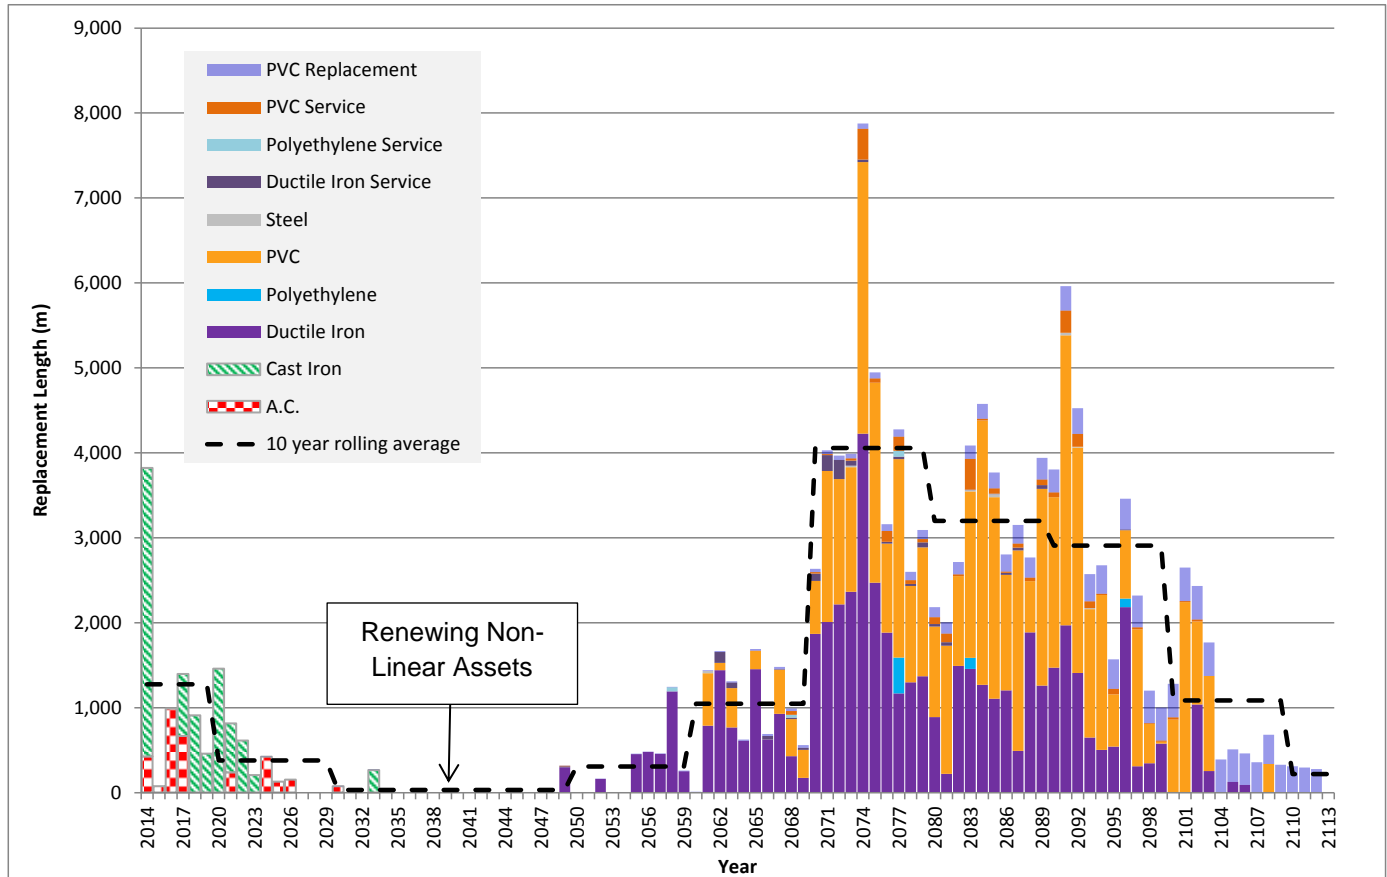
Figure 3-1: Long Term Pipe Replacement – Length by Material

length of pipe is triggered for replacement when the risk tolerance is exceeded. The revised schedule of interventions per year for the next 100 years is presented in [Figure 3-1](#).

The 30 year interval between roughly 2025 and 2055 present a fortunate period to plan and manage the significant renewal demands of the mid-21st century. This interval also presents a timeframe where renewals can be concentrated on the water utility non-linear assets. Most of these assets do not have as long a service life as water mains, and will require some rehabilitation during this period.

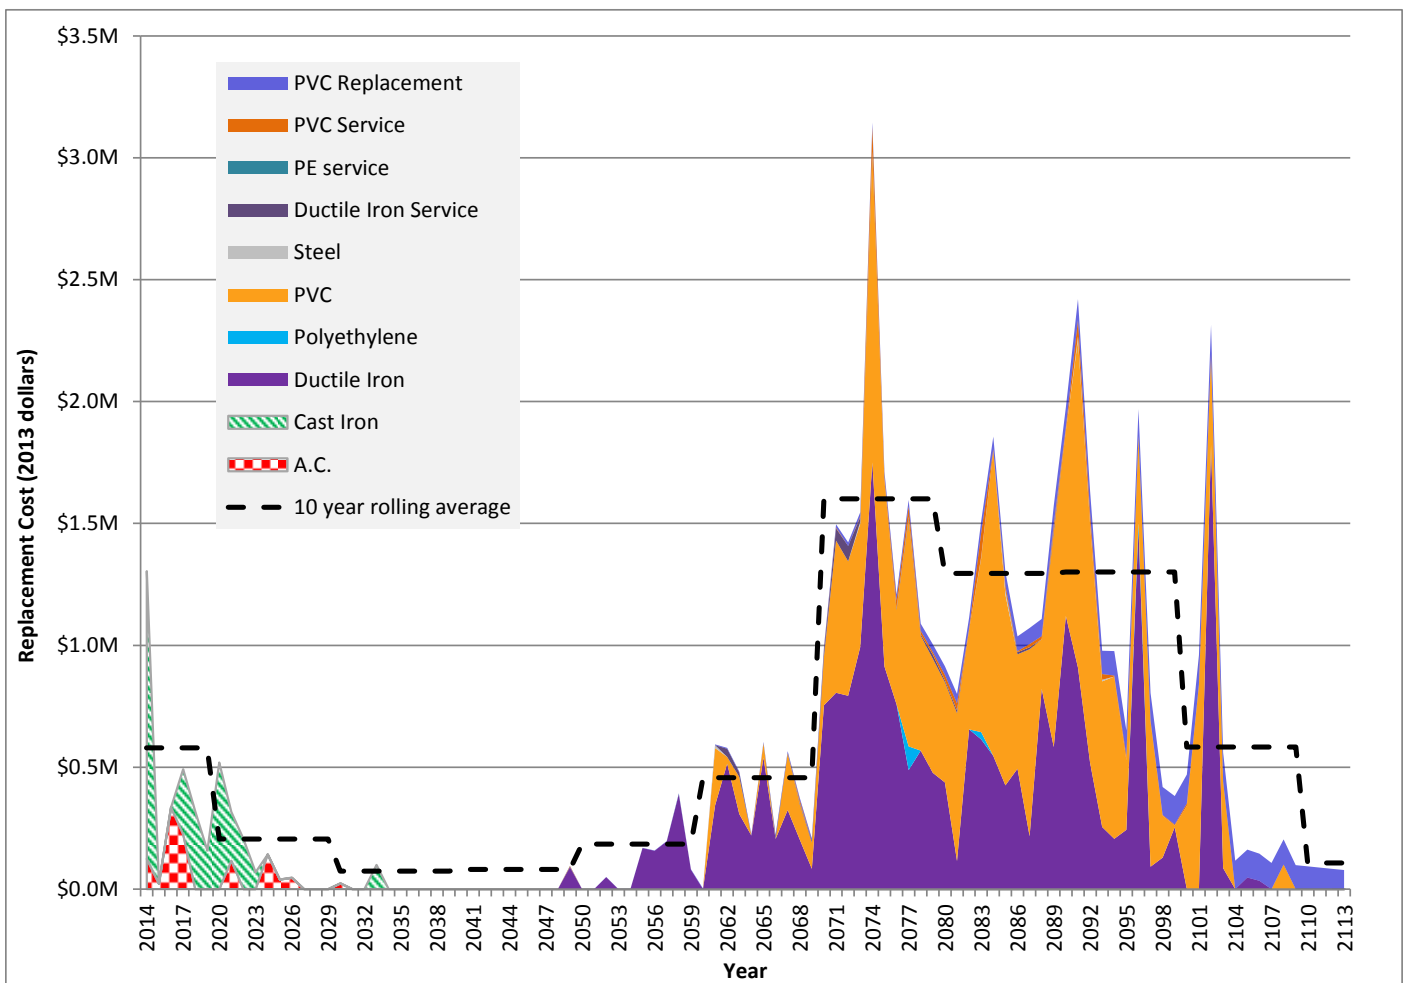
Figure 3-2: 100 Year Renewal Budget Estimates for Linear Assets

Figure 3-2 below presents an estimate of the 100 year renewal budget estimates based on the revised bottom-up assessment. In addition to the yearly estimates, the graph includes a 10 year rolling budget average.

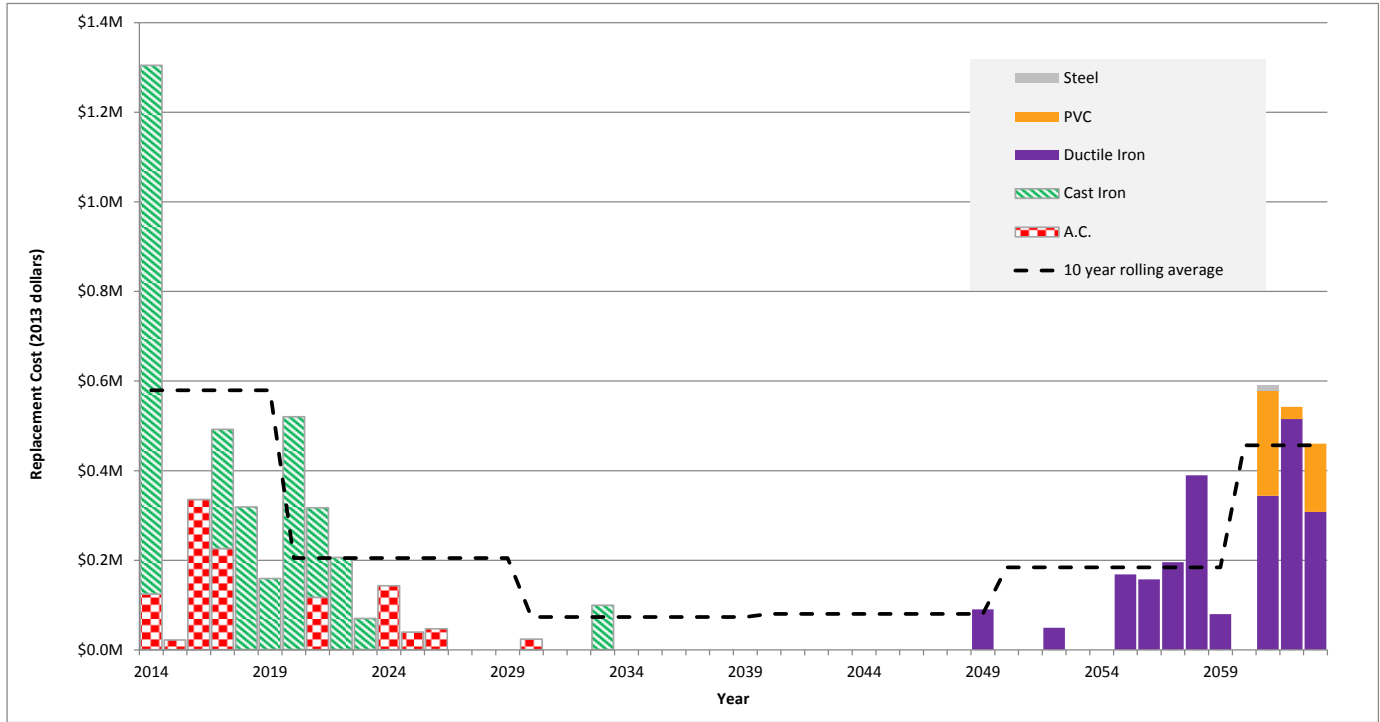
Figure 3-3: 50 Year Renewal Budget Estimates for Linear Assets

To provide a closer examination of the shorter term renewal funding requirements, the 50 and 25 year horizon are presented below in **Figure 3-3** and **Figure 3-4**:

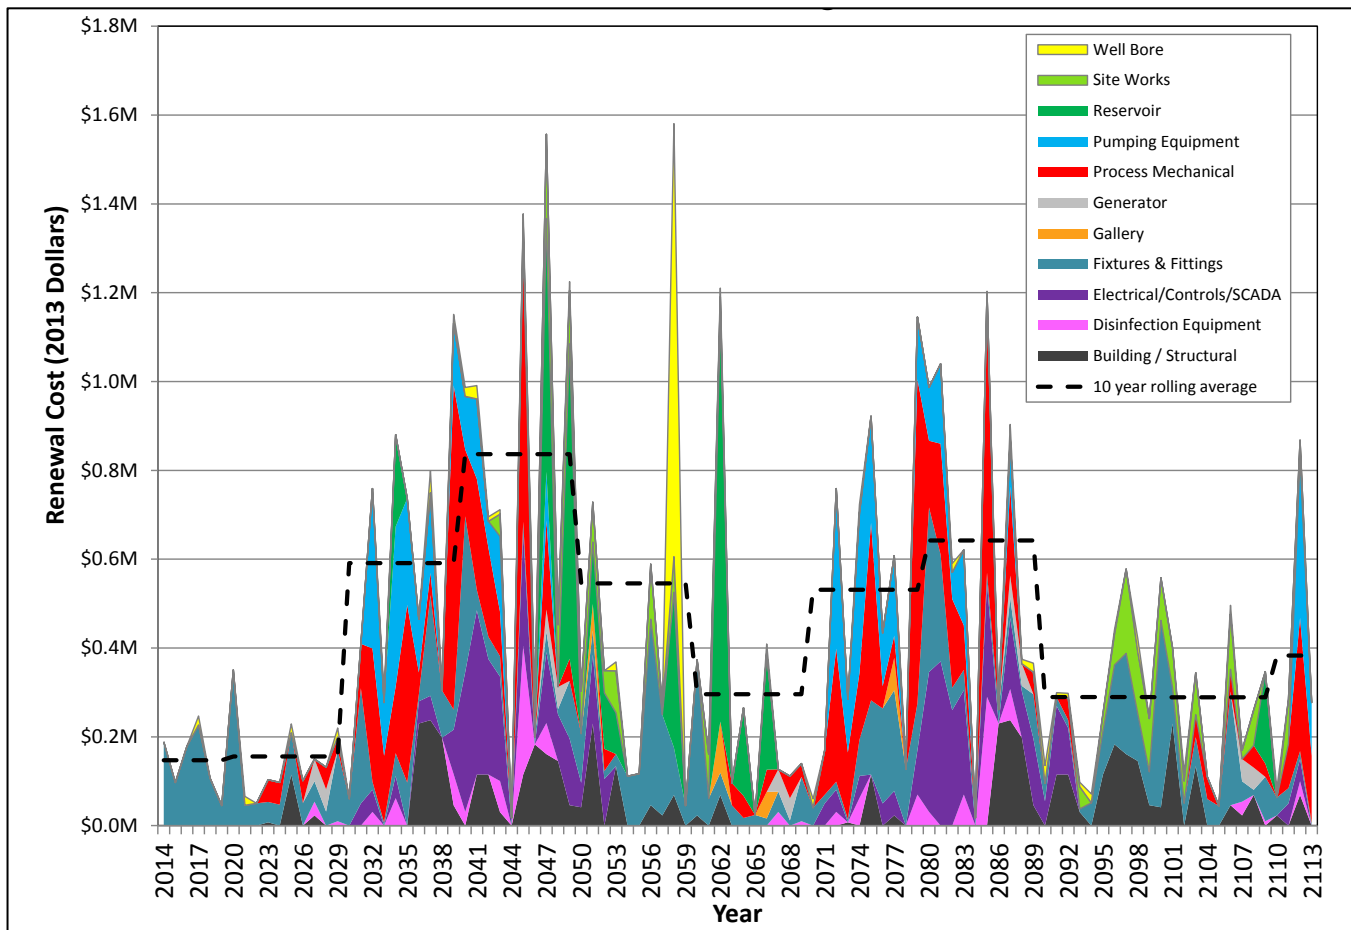
Figure 3-5: 100 Year Renewal Budget Estimate for Non-Linear Assets

The bottom up analysis of the non-linear assets presents a similar picture to the linear asset renewal forecast in that there are two waves of renewal expected within the next 100 years. Based on the condition assessment of the assets many of the renewal expected in the near future are delayed. Over the next 100 years, the average annual cost to renew and replace the entire inventory of non-linear assets is approximately \$ 442,000 per year for a total expenditure of \$ 44,200,000 (expressed in 2014 dollars). Again there are two periods of intense renewal requirements that occur from 2030 to 2059, and then from 2070 to 2089. The result of the analysis is presented in [Figure 3-5](#).

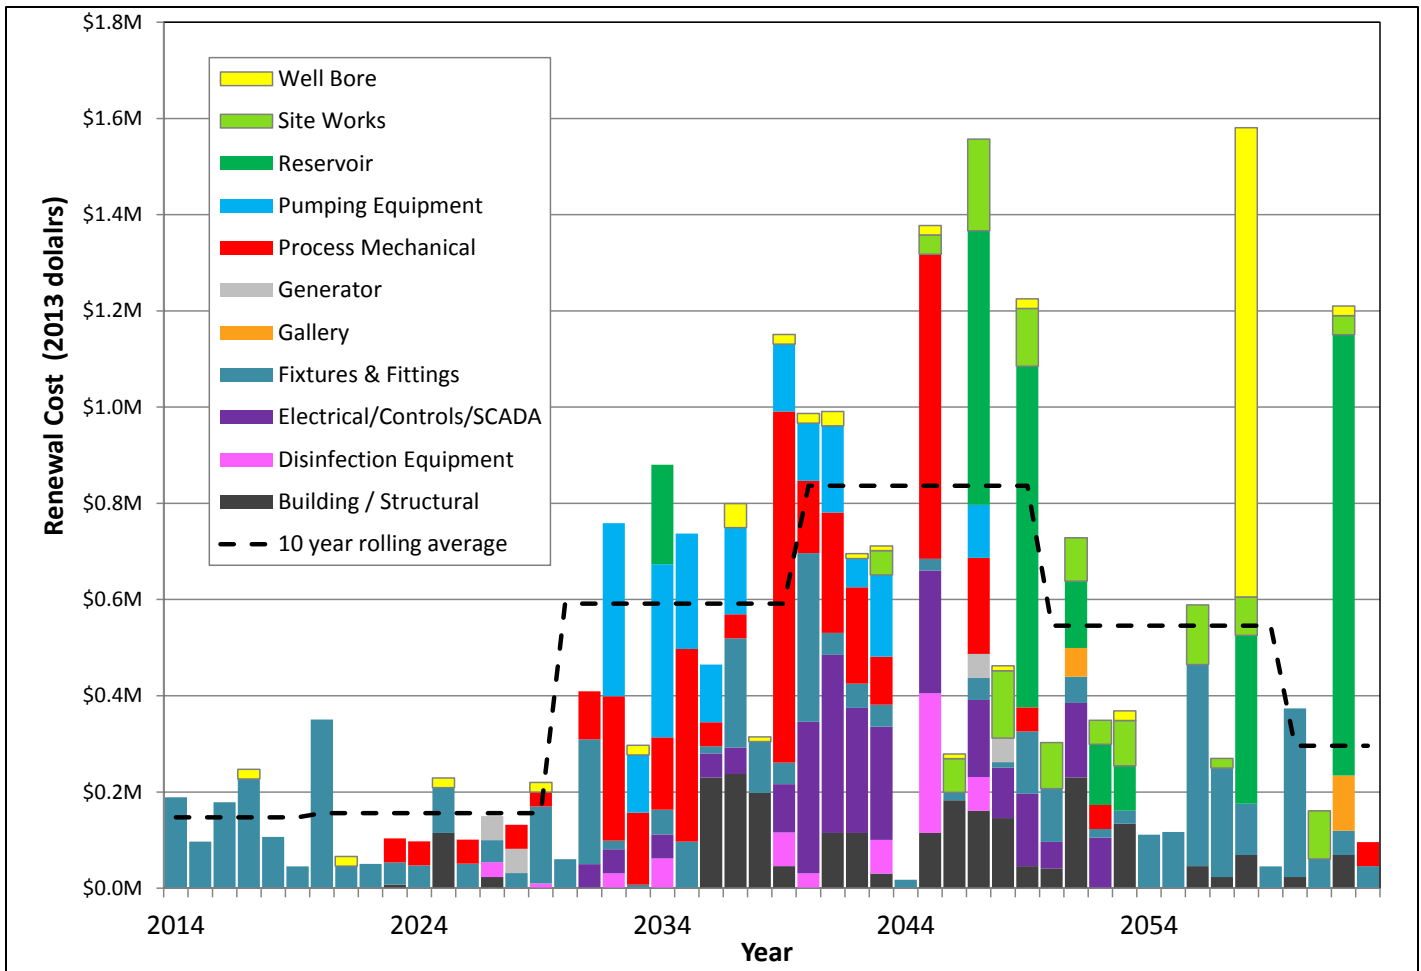
Figure 3-6: 50 Year Renewal Budget Estimates for Non-Linear Assets

To provide a closer examination of the shorter term renewal funding requirements, the 50 and 25 year horizon are presented below in [Figure 3-6](#) and [Figure 3-7](#).

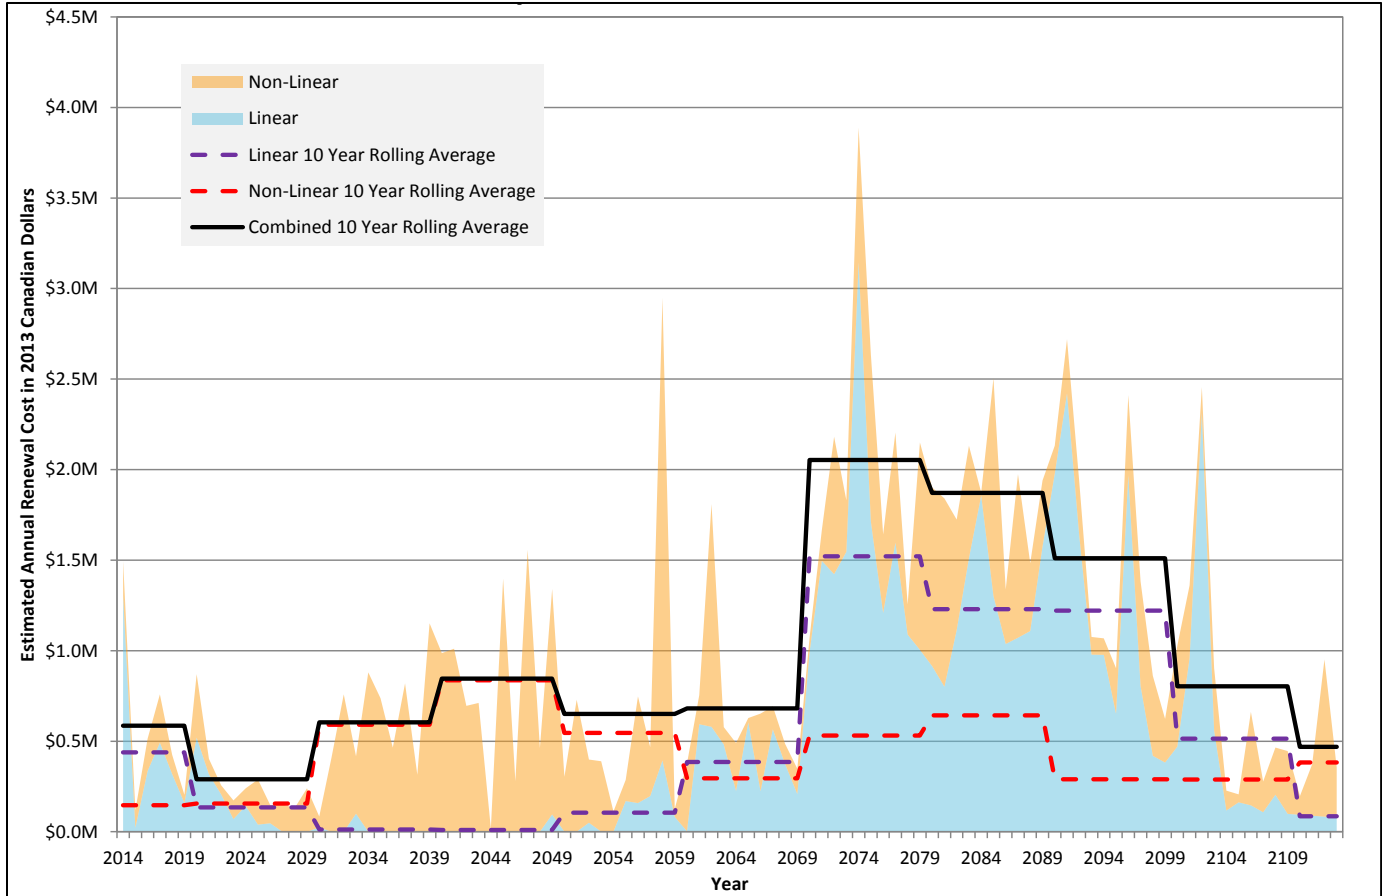
Figure 3-8: 100 Year Combined Renewal Budget Estimates

When the two 100-year bottom-up forecasts are combined they yield the forecast presented in [Figure 3-8](#).

The forecast shows that in the immediate future the renewal of the water mains will be the priority for RMoW, followed by a period of approximately 30 years where the focus will be on renewal of the non-linear infrastructure. In the latter half of the century the larger second renewal waves for the linear and non-linear assets coincide, with costs forecast to peak in 2074 at approximately \$ 3.9 M.

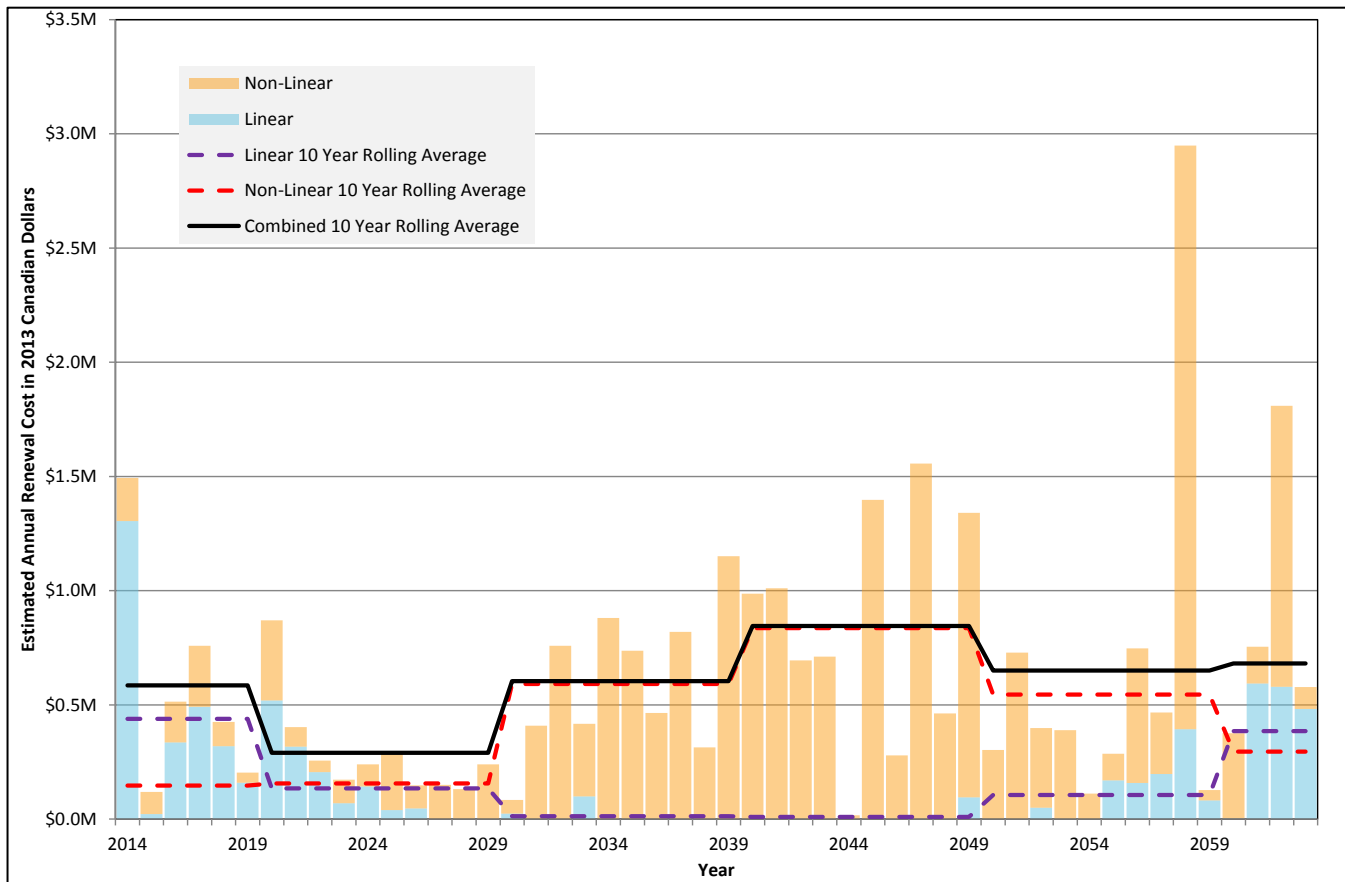
Figure 3-9: 50-Year Combined Renewal Budget Estimates

To provide a closer examination of the shorter term renewal funding requirements, the 50 and 25 year horizon are presented below in [Figure 3-9](#) and [Figure 3-10](#).
