Water Utility Infrastructure Rehabilitation Study

Resort Municipality of Whistler
4325 Blackcomb Way
Whistler, BC V0N 1B4

March 18, 2014

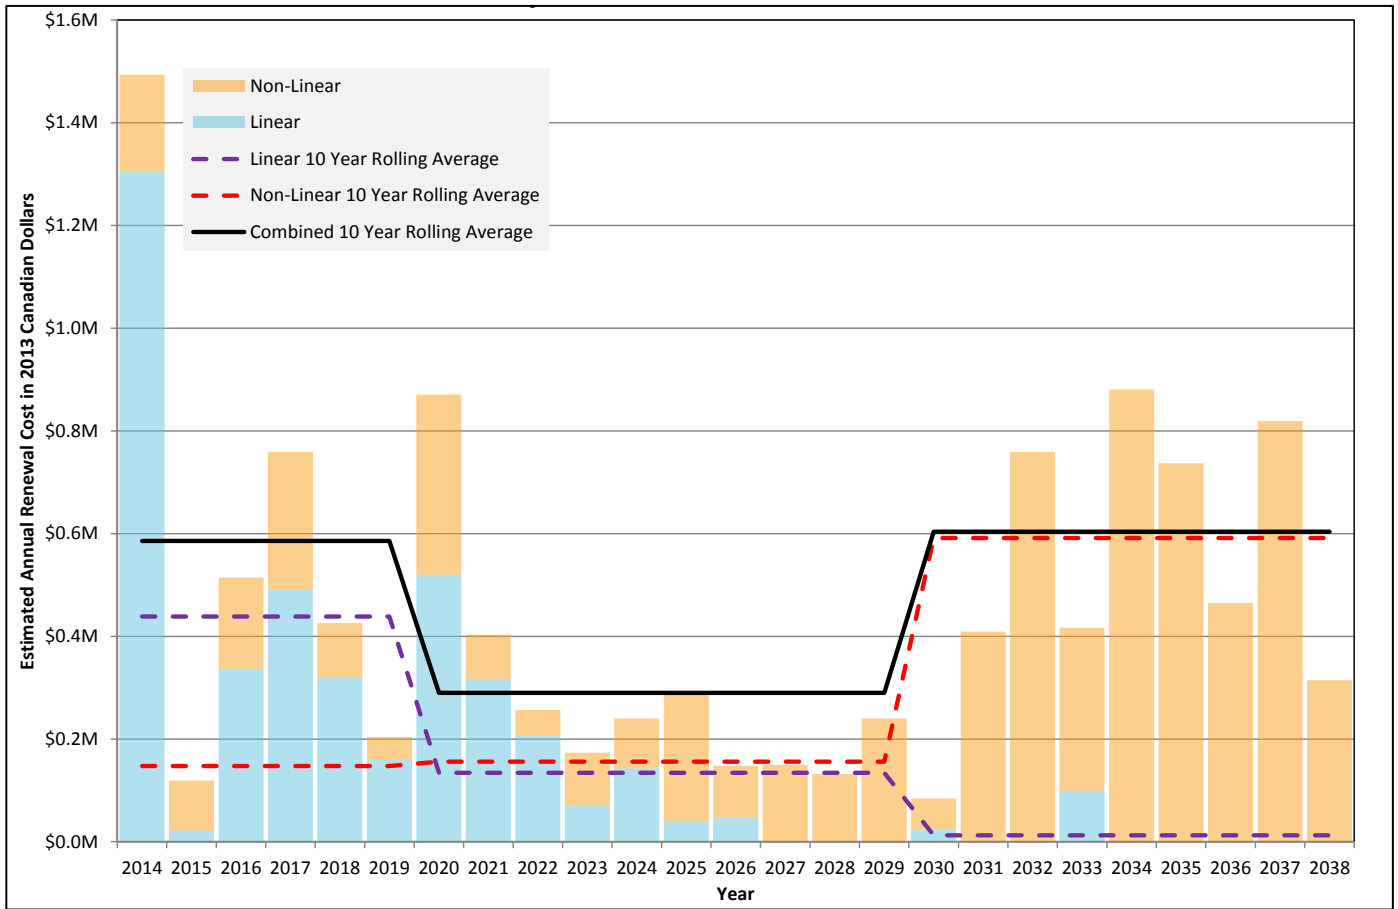
Figure 3-10: 25-Year Combined Renewal Budget Estimates

To provide a closer examination of the shorter term renewal funding requirements, the 50 and 25 year horizon are presented below in [Figure 3-9](#) and [Figure 3-10](#).

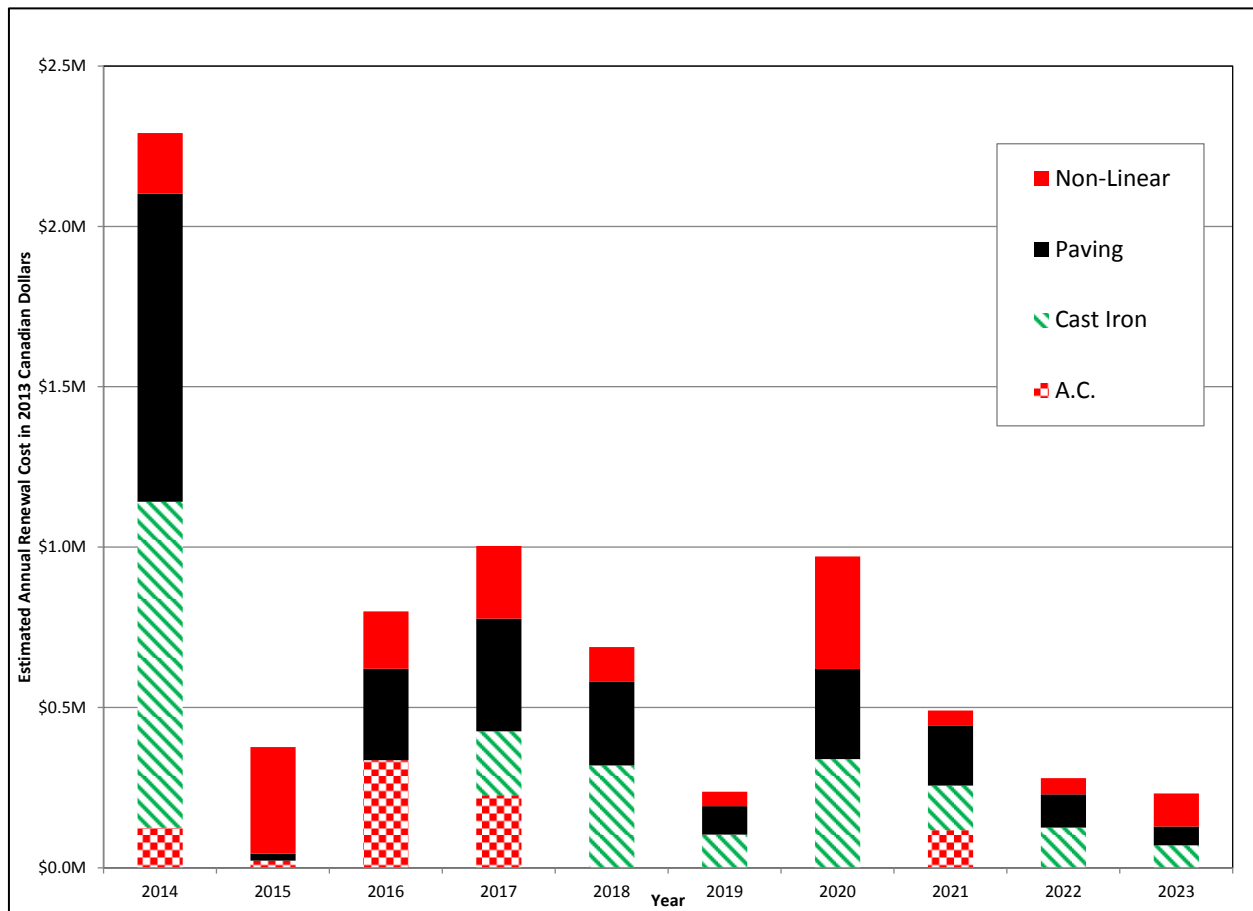
Figure 5-1: 10 Year Capital Renewal Forecast

The information gathered through this assessment can now be used to help prepare a financial plan to deal with pending infrastructure renewal projects and activity. [Figure 5-1](#) below shows the 10 year average funding required to conduct the prioritized water distribution system renewals. This needs to be added to the RMoW Capital Plan over the next few years.

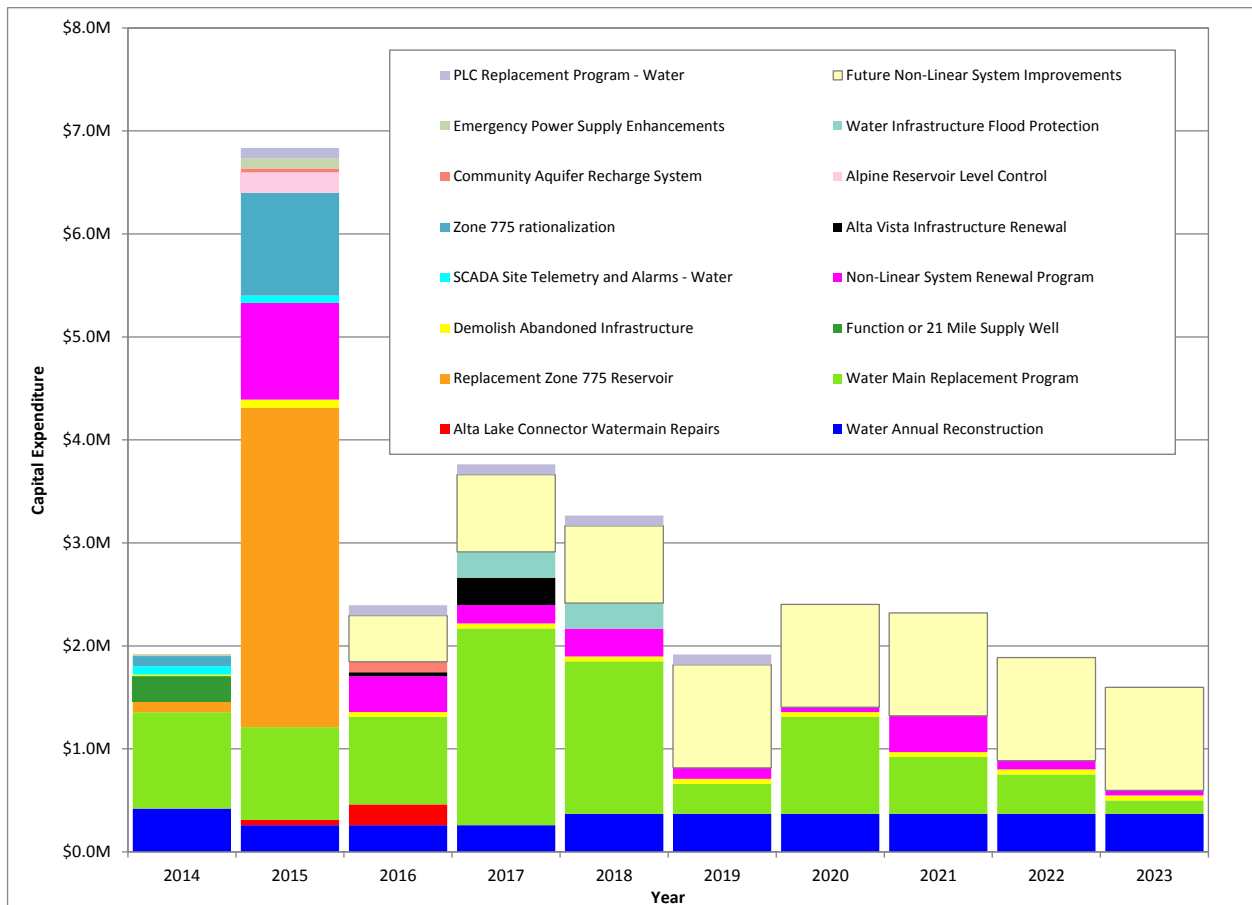
Figure 5-2: RMoW 10 Year Capital Expenditures

The capital expenditures are presented graphically in Figure 5-2 below.

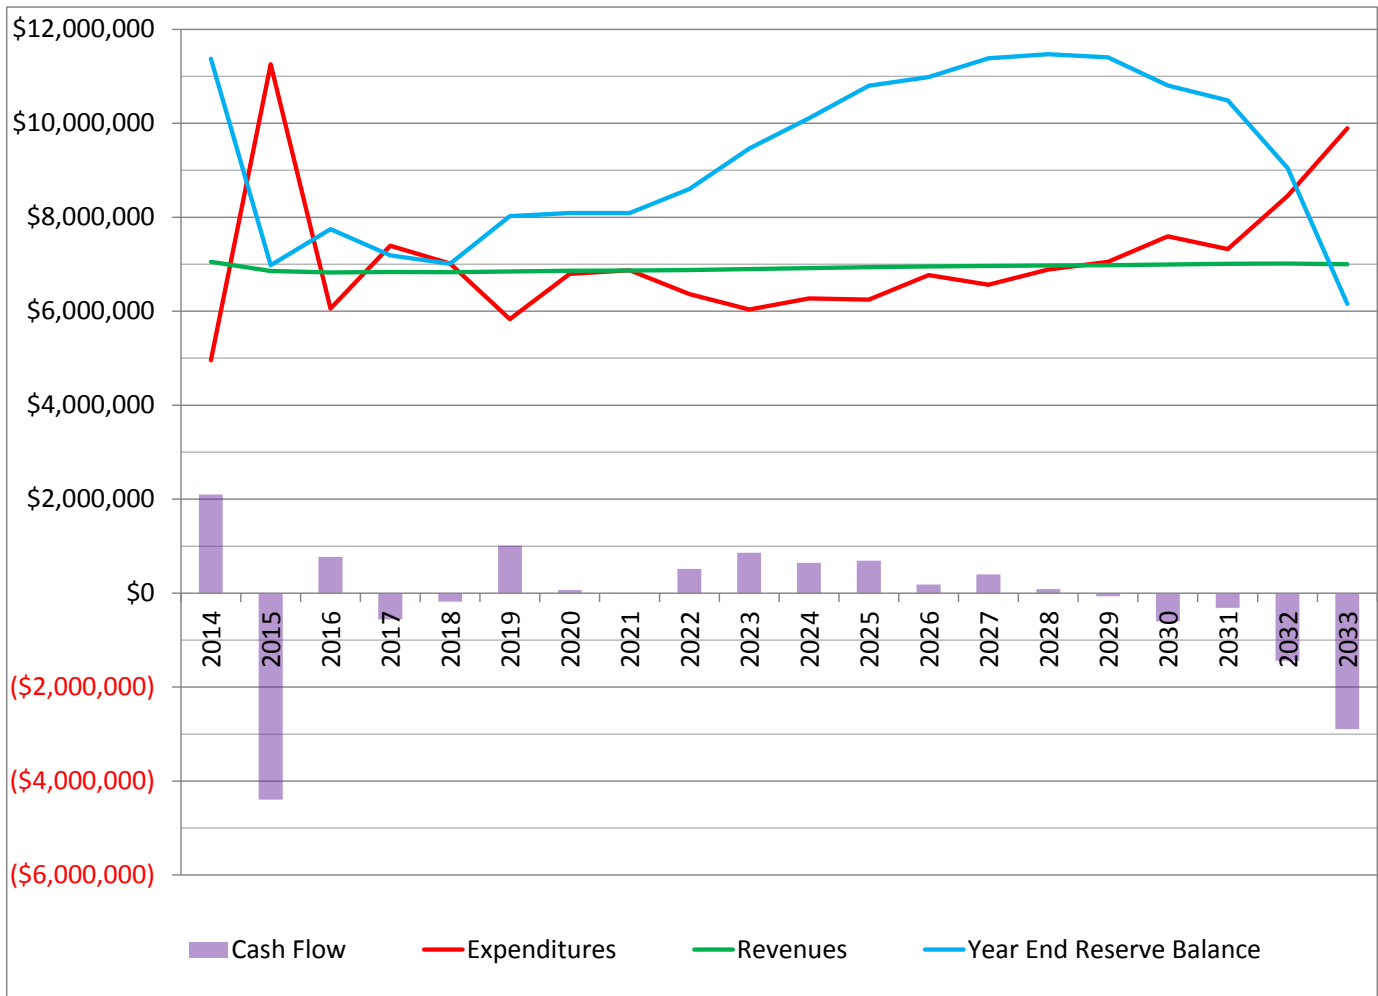
Figure 5-3: Twenty Year Reserve Balance Forecast

The twenty year forecast showing capital and operating expenditures, revenues, cash flow and end of year reserves is presented in **Figure 5-3**.

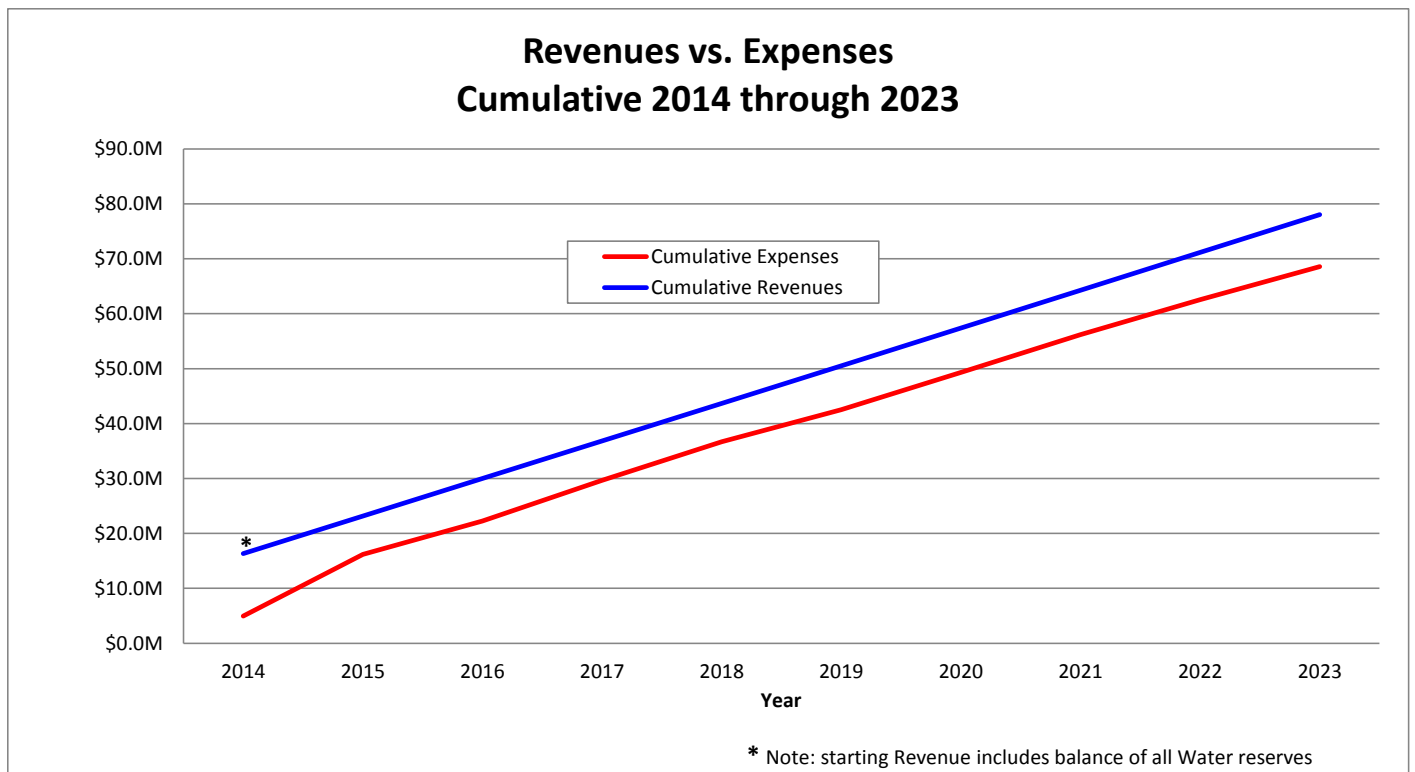
Figure 5-4: Cumulative Costs and Revenues over the next 10 years

RMoW is recommended to fund the water distribution system renewal program projects through a debt free funding strategy using rates and/or reserves. The debt free funding recommendation applies to the replacement of existing infrastructure because it results in the least cost funding alternative when compared to using debt. Currently budgeted contributions to reserves are sufficient to fully fund the renewal program and still result in a growing reserve balance from year to year after 2014 to 2023. The cumulative costs and revenues through 2023 are presented in [Figure 5-4](#).

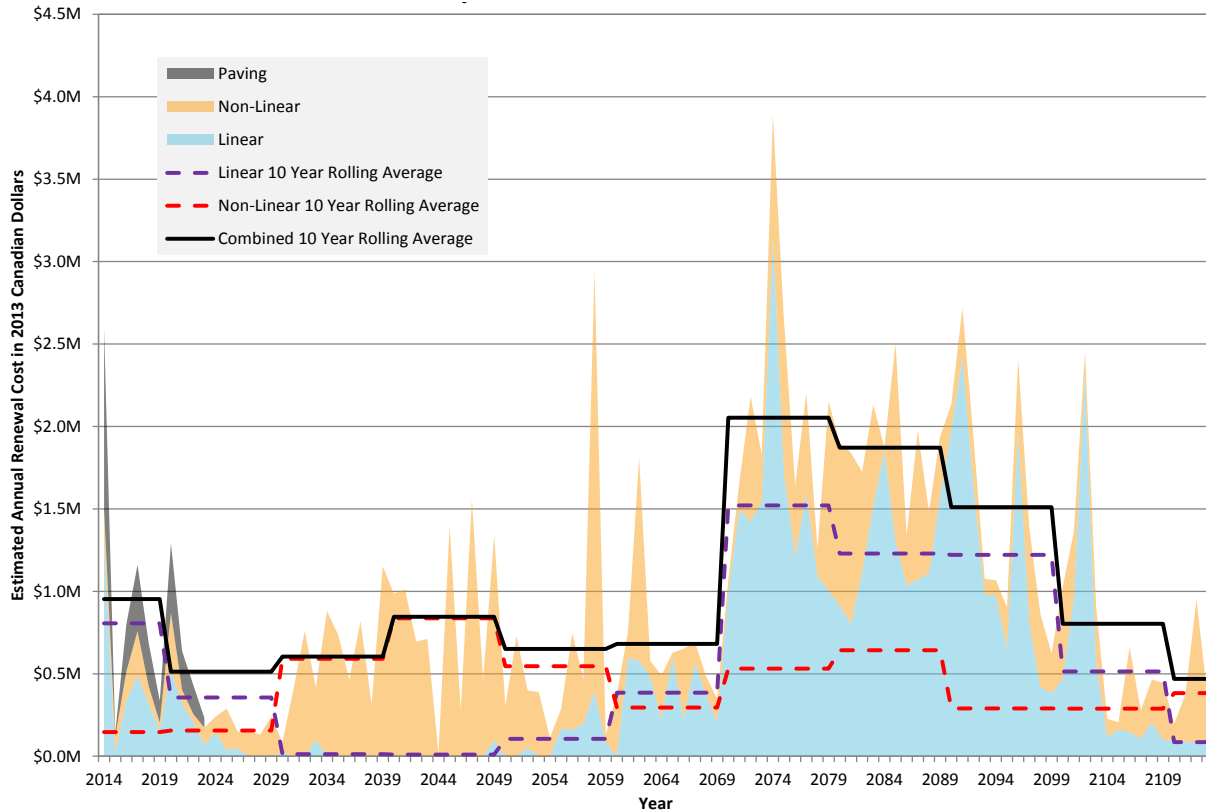
Figure 5-5: 100 Year Renewal Budget Estimates

Figure 5-5 below shows the long range funding needs along with the estimated 10 year rolling funding average.

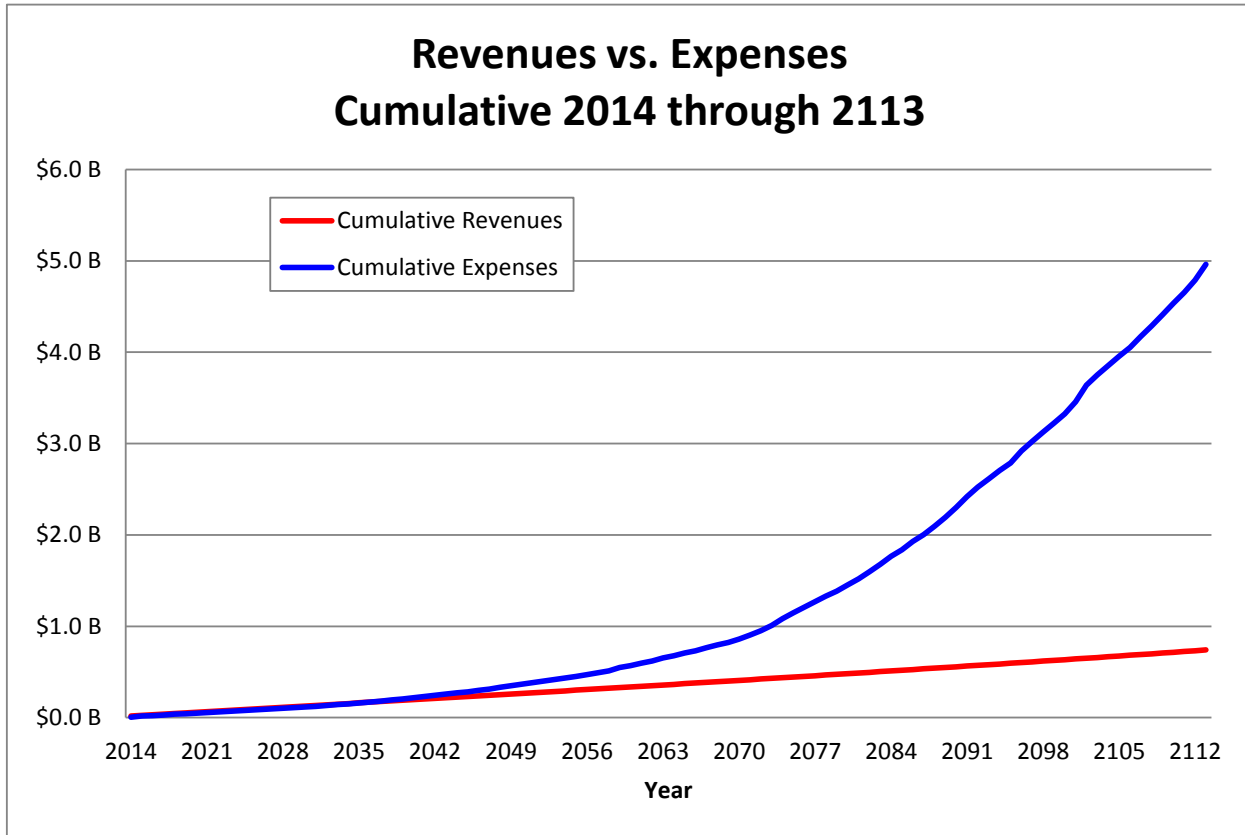
Figure 5-6: Cumulative Costs and Revenues over the next 100 years

Using a projection of expected costs provided by RMoW over the next 100 years to 2113 the cumulative revenues and expenses is presented in Figure 5-6. It can be seen that revenues are adequate until around the year 2035, beyond which the cumulative expenses are expected to accelerate. Without a change in rates or other funding sources the RMoW may not be able to meet the Levels of Service required for its water utility.

*Note: an engineering evaluation of the 100 year capital forecast has not been undertaken as part of this study.

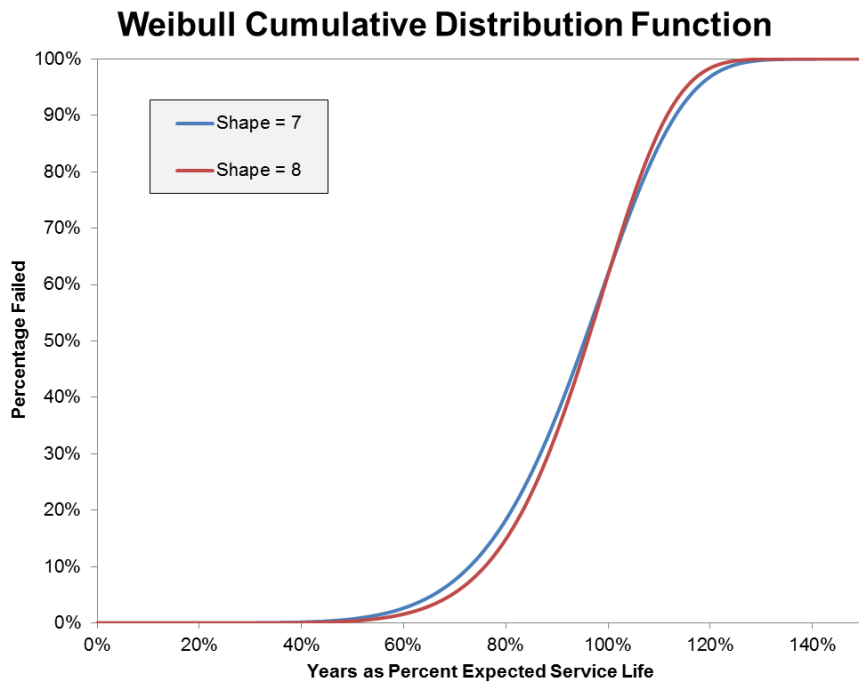
Figure C - 1 Cumulative Distribution Function with Varying Shape Parameters

The scale parameter is related to the expected life of the pipeline, and the shape parameter is related to the rate of deterioration. If we substitute years with percent expected service life, altering the scale parameter will not alter the form of the curve. Based on published data for Weibull PDFs of pipeline deterioration, the shape factor tends to fall between 7 and 8, the cumulative distribution function can then be plotted as in **Figure C - 1**.
