# Annual Drinking Water Report 2023

Resort Municipality of Whistler

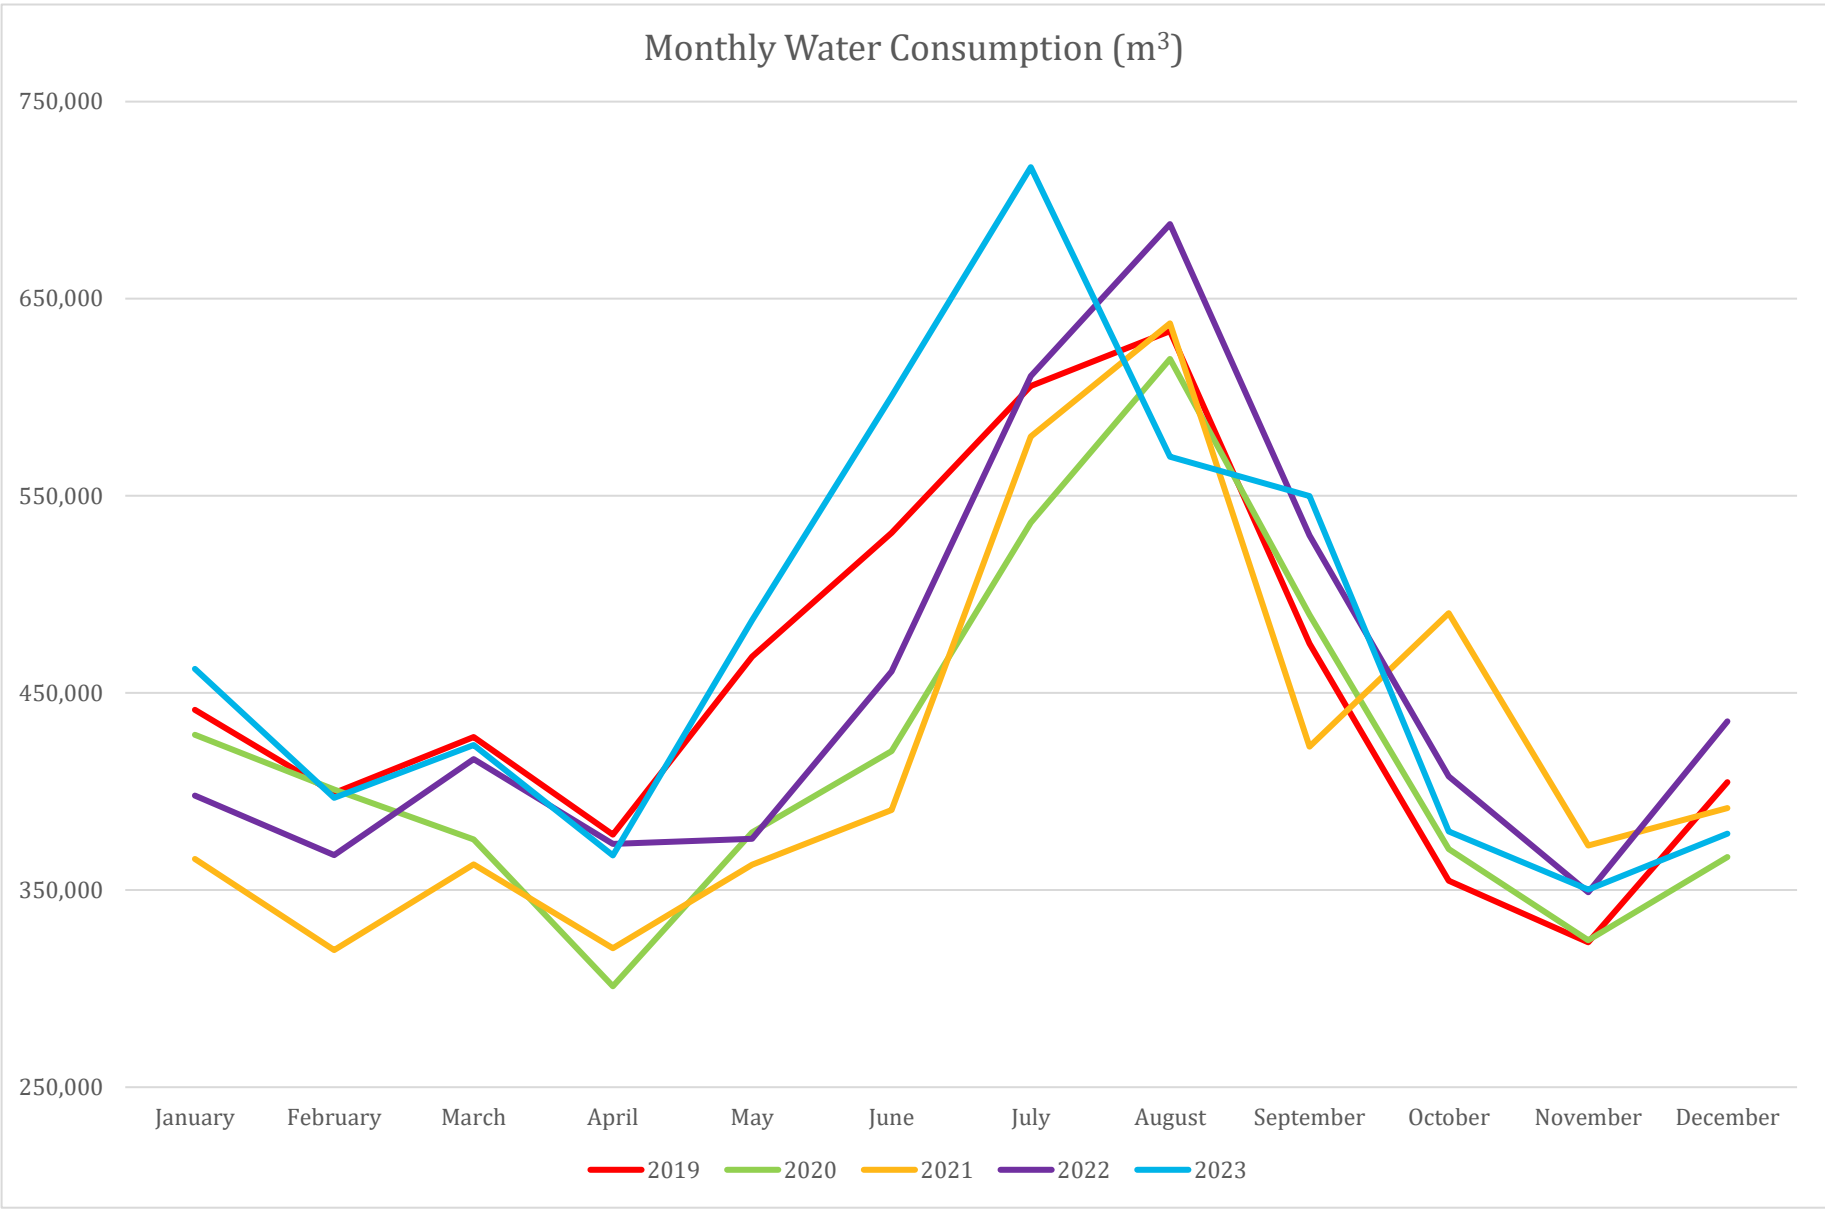
Figure 4: Monthly Water Consumption 2019 - 2023 (m<sup>3</sup>)

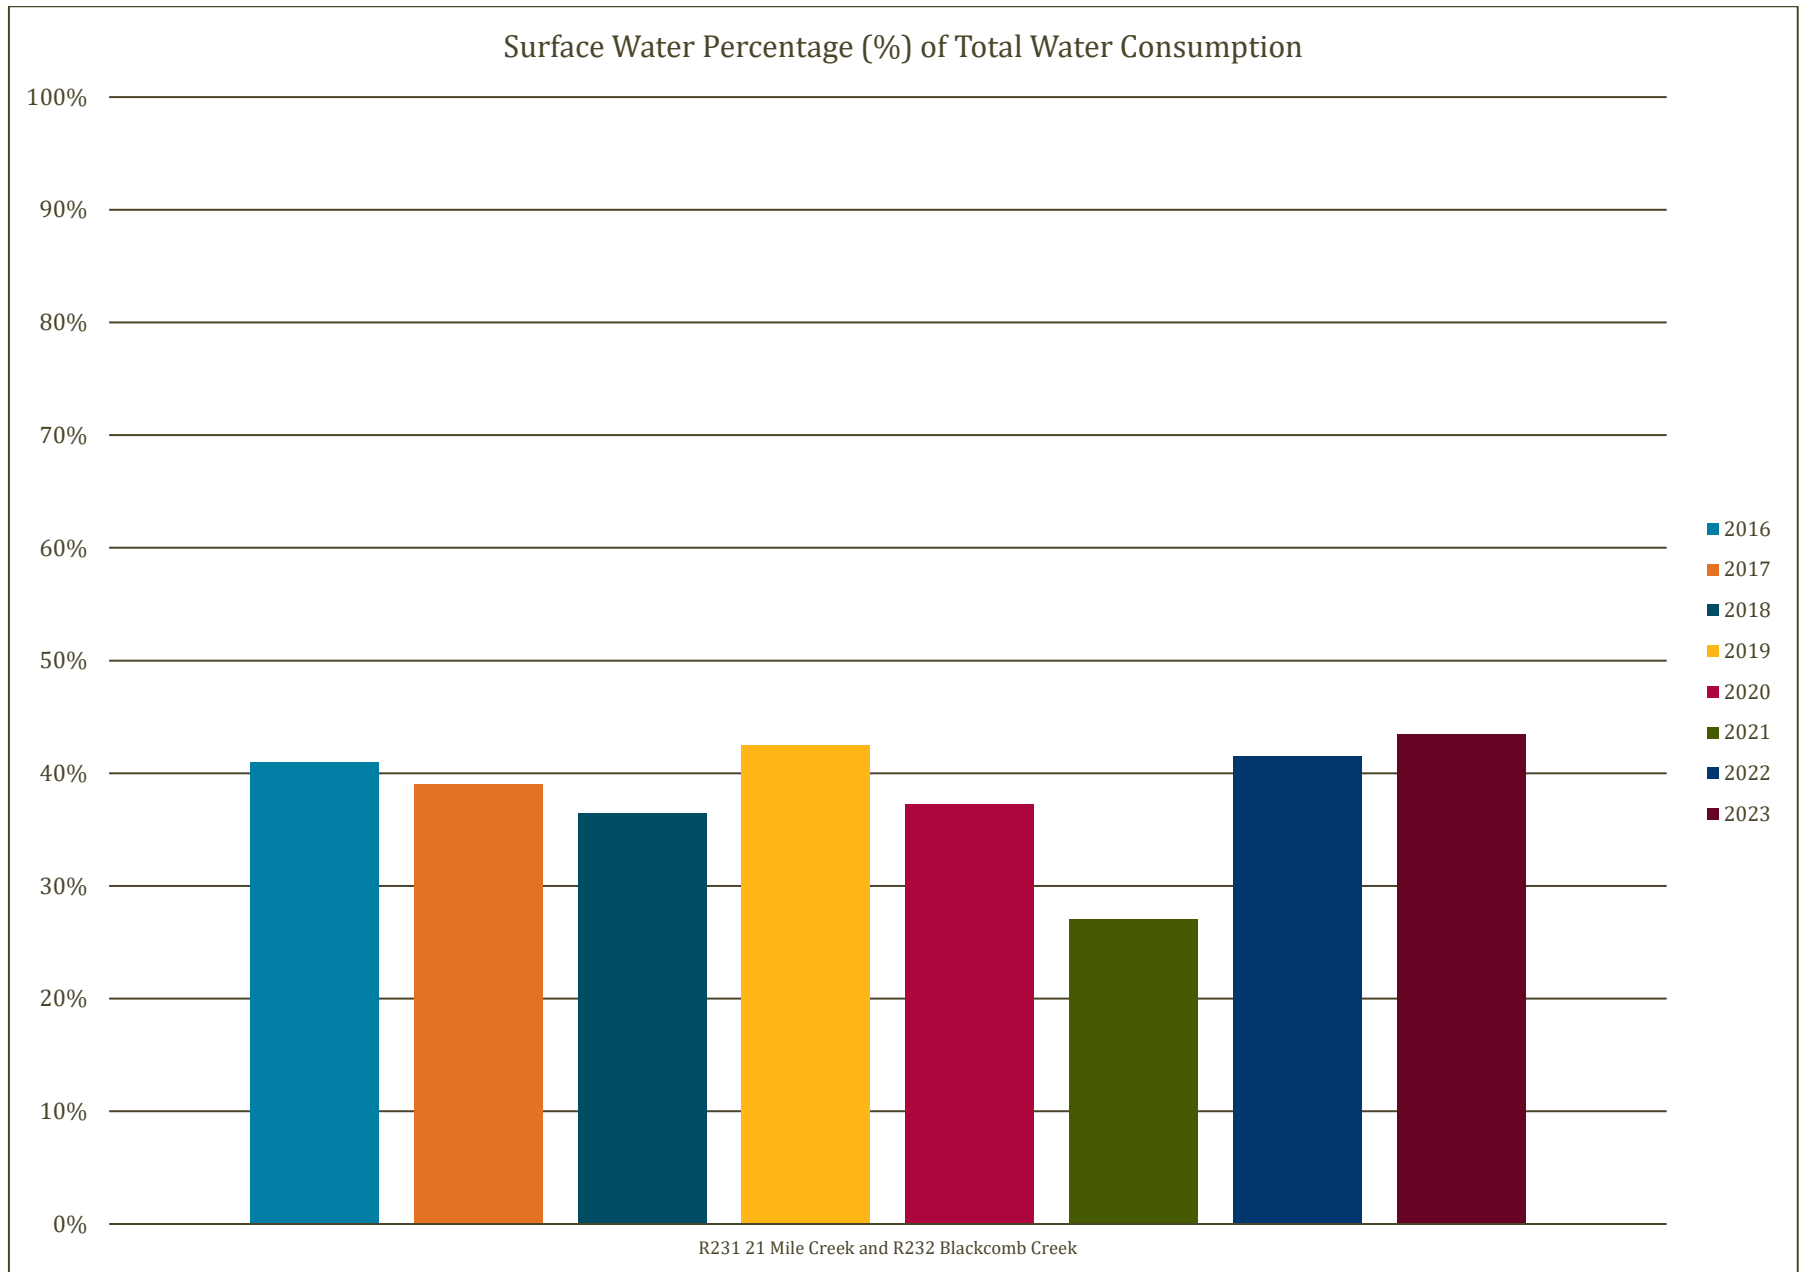
Figure 6: Surface Water Percentage (%) of Total Water Consumption 2016 - 2023

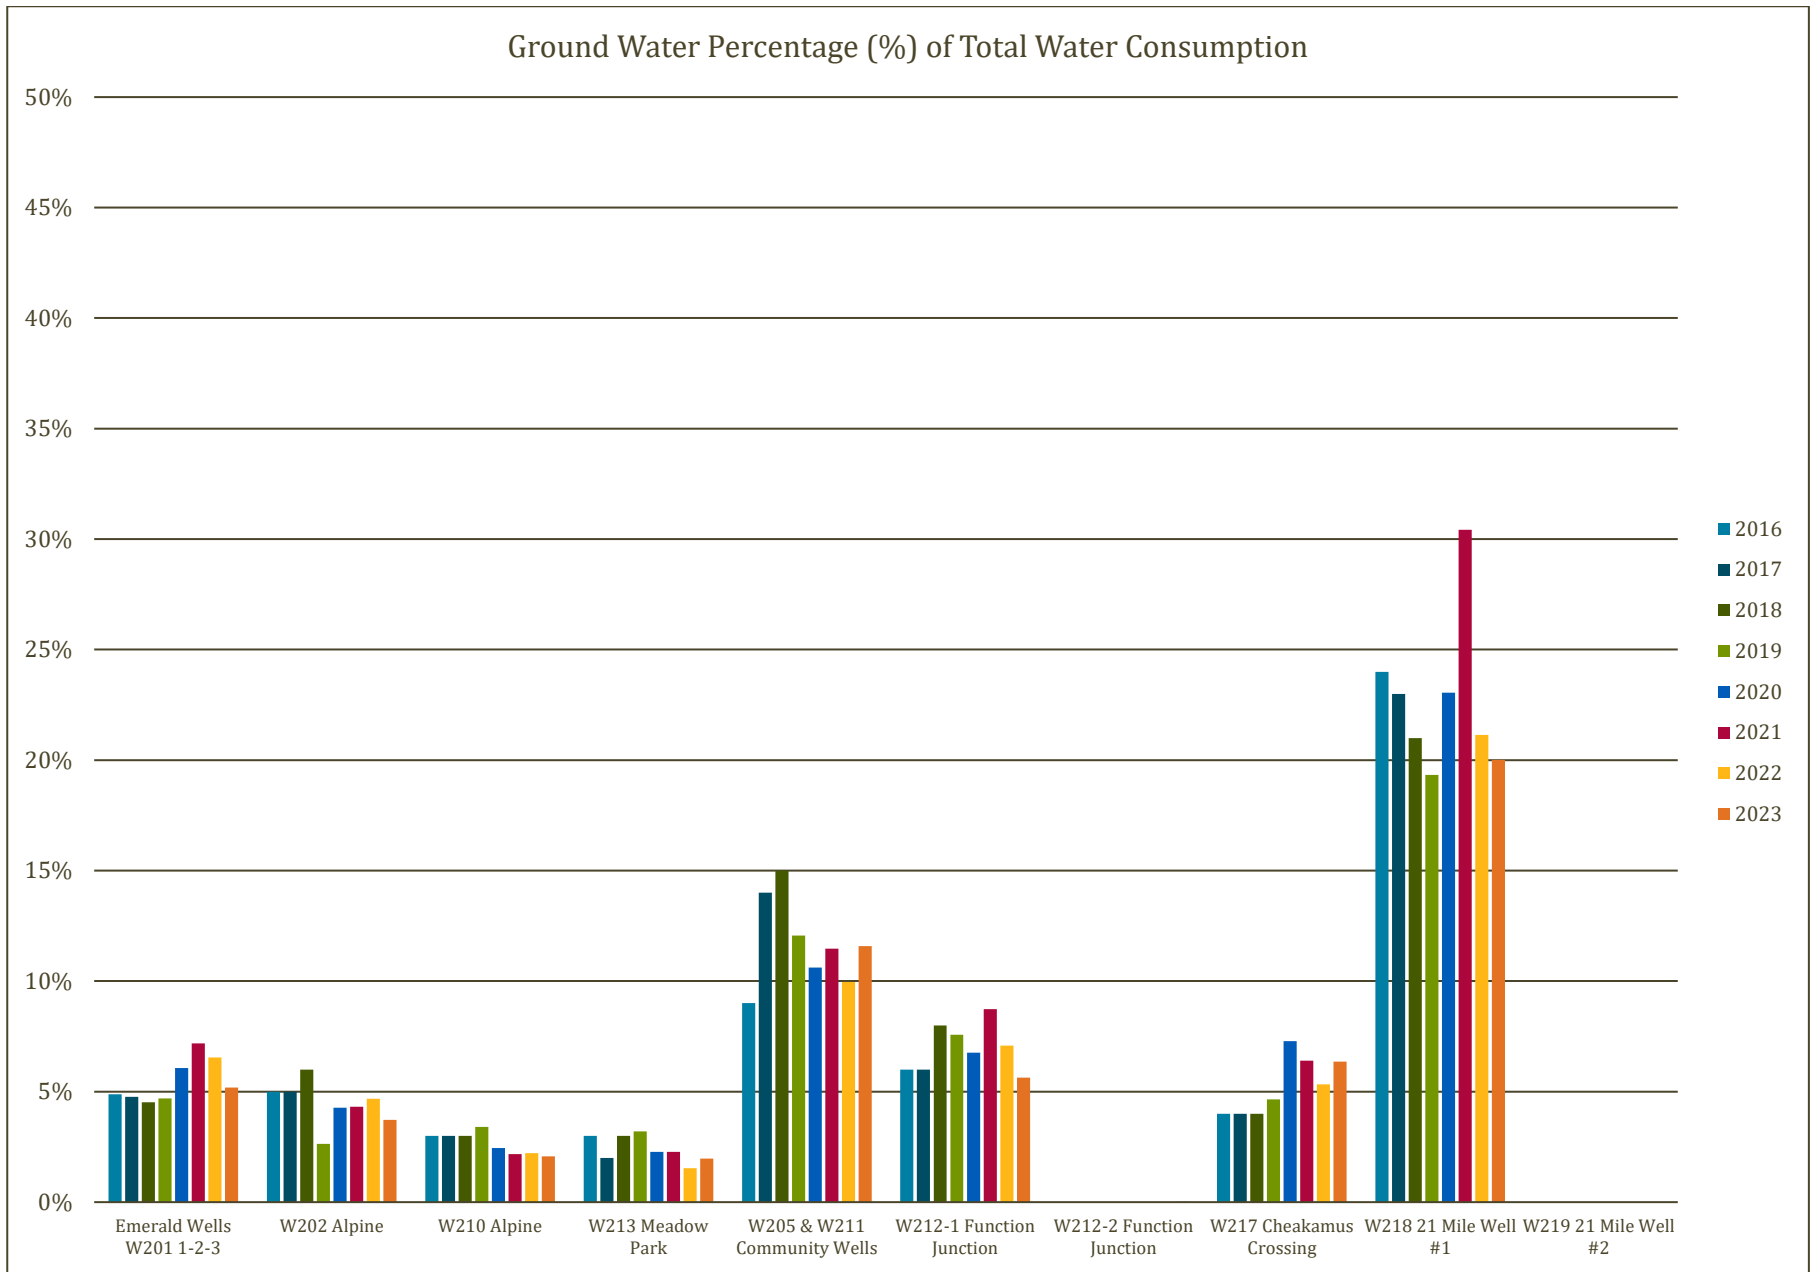
Figure 7: Ground Water Percentage (%) of Total Water Consumption 2016 - 2023
